BLM Authorized Officer Weekly Report

Project: Tule Wind Energy Project

Weekly Project Update

Reporting Period: 1.9.17 through 1.15.17

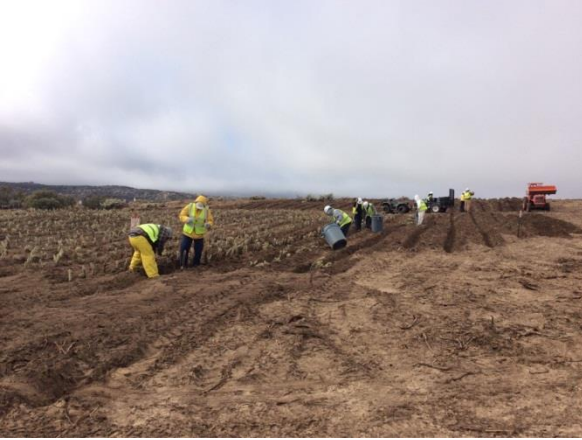
Previously salvaged cacti segments were planted along the J string during this reporting period and are anticipated to be re-planted post-construction in accordance with Section 5.2.2.1 of the Habitat Restoration Plan.

Photo 1: Previously salvaged cacti are being temporarily planted along the J string. The cacti are anticipated to be re-planted post-construction in accordance with Section 5.2.2.1 of the Habitat Restoration Plan.

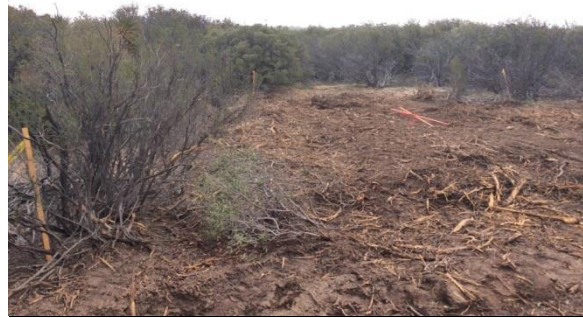
At approximately 11:00 am, on Wednesday, 1.11.17 the BLM's third party cultural monitor notified BLM's third party compliance monitor of a potential compliance issue where a skid steer with a mulching attachment had operated past the staked limits of disturbance along F string on lands administered by the BLM. Vegetation was mulched past the limits of disturbance by approximately 20 feet impacting approximately 230 square feet of vegetation. The operator cleared up to what he thought was the staked disturbance limit, but did not recognize that one of the stakes was an "off-set" stake that was intentionally placed off the ROW.

Photo 2: On 1.11.17, approximately 230 square feet of vegetation was mulched outside of the limits of disturbance. This event is being classified as a "Non Compliance" in accordance with Section 5.2 of the ECCMP.

The BLM's third party compliance cultural and compliance monitors surveyed the area outside the disturbance limits and found no impacts to biological or cultural resources. The BLM is working with Tule Wind LLC to document the non-compliance and to take measures to prevent similar issues from occurring. Staking crews will begin placing "off-set" stakes inside the limits of disturbance to reduce the potential for confusion.

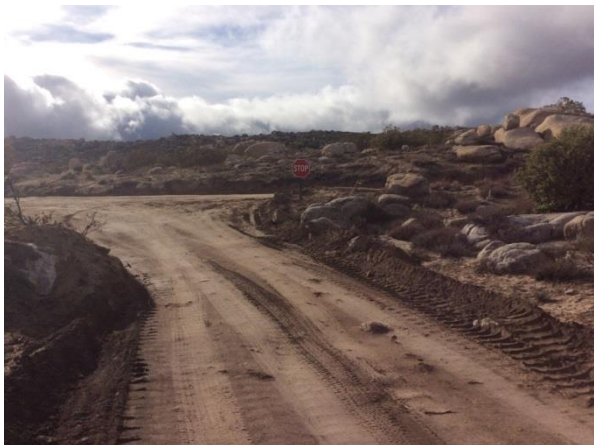
Photo 3: Stop sign installed along the H string access road AA in accordance with the approved Traffic Control Plan and MM TRA-1.

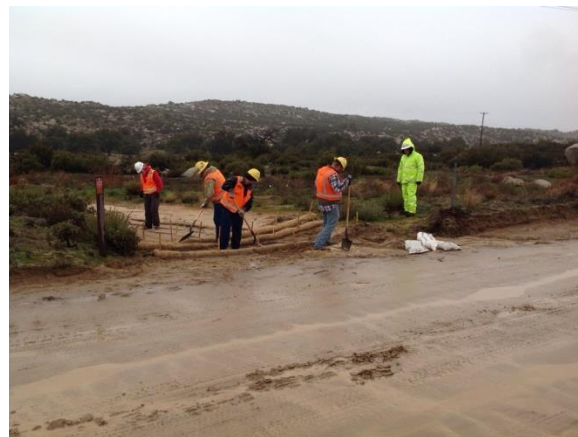
Due to recent and on-going rain events, numerous erosion and sediment control devices were in need of maintenance and repair. In several cases the erosion and sediment control devices were laden with sediment and in other cases were ineffective as water was flowing beneath the device rather than through the device. Each of these issues were documented and reported to Tule Wind, LLC. Dedicated construction crews are in the process of repairing, maintaining, and installing erosion and sediment control devices.

Photo 4: Crews installing additional straw wattles and maintaining existing erosion and sediment control devices along McCain Valley Road in accordance with the SWPPP and MM HYD-1. Cultural monitors were present to observe ground disturbance associated with the installation and maintenance of sediment control devices in accordance with MM CUL-1D.
