## BLM Authorized Officer Weekly Report

**Project:** Tule Wind Energy Project

### Weekly Project Update

**Reporting Period:** 1.16.17 through 1.22.17

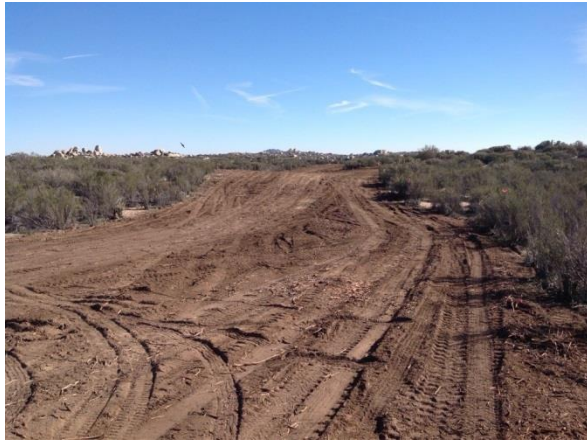
On Wednesday, 1.18.17 the BLM's third party ECM observed a compliance issue where vegetation had been grubbed within the proposed disturbance limits of Variance Request 003, which had not yet been approved. Upon inspection, the ECM and Designated Biologist observed that the grubbing had occurred within the staked limits; however the stakes were placed at the limits designated in Variance 003, which is pending BLM review and approval. The area impacted outside of the currently approved disturbance limits was approximately 11,700 square feet. The BLM's third party cultural and environmental compliance monitors surveyed the area outside the currently approved disturbance limits and found no impacts to biological or cultural resources.

**Photo 1:** On 1.18.17, approximately 11,700 square feet of vegetation was mulched outside of the currently approved limits of disturbance. BLM issued a “Non Compliance” in accordance with Section 5.2 of the ECCMP.

A non-compliance was issued by the BLM for this incident due to work occurring outside of the approved work limits per MM-BIO-1A. Tule Wind LLC is in the process of preparing a corrective actions memorandum to provide BLM with a process that will be implemented moving forward to minimize the potential for a similar incident to not occur in the future.

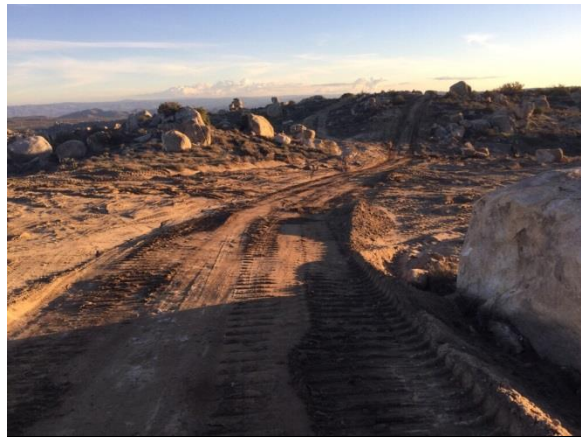
On Monday, 1.16.17, the BLM's third party cultural monitor observed a blade grading the G string access road between structures G7 and G6 in a previously disturbed area without cultural monitors present. The third party cultural monitor notified the lead archaeologist who sent an archaeological and Native American monitor to cover the activity. No resources were determined to be impacted as a result of this event. A non-compliance was issued by the BLM for this incident due to a monitor not being present in an area that required monitoring per MM-CUL-1D. Tule Wind LLC is in the process of preparing a corrective actions memorandum to provide BLM with a process that will be implemented moving forward to minimize the potential for a similar incident to not occur in the future.

**Photo 2:** On 1.16.17, a BLM third party cultural monitor observed a blade operating in a previously disturbed area along the G string access road between structures G7 and G6 without a cultural monitor present. BLM issued a “Non Compliance” in accordance with Section 5.2 of the ECCMP.

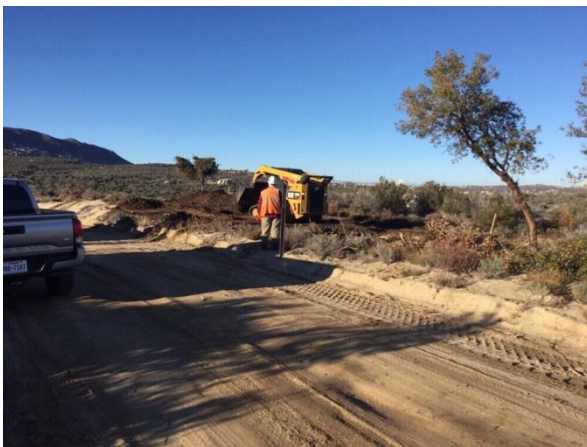
**Photo 3:** Cultural monitors were observed monitoring vegetation removal and grading activities along McCain Valley Road in accordance with MM CUL-1D.

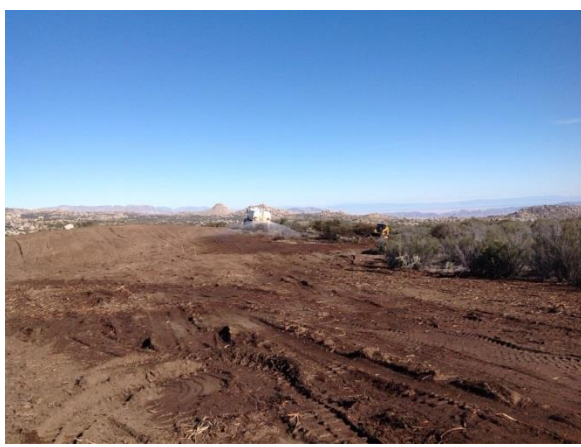
**Photo 4:** Water trucks were observed working alongside grubbing machines in accordance with the approved Fire Prevention/Protection Plan (MMs FF-1 and BIO-1F).
