## BLM Authorized Officer Weekly Report

**Project:** Tule Wind Energy Project

### Weekly Project Update

**Reporting Period:** 1.23.17 through 1.29.17

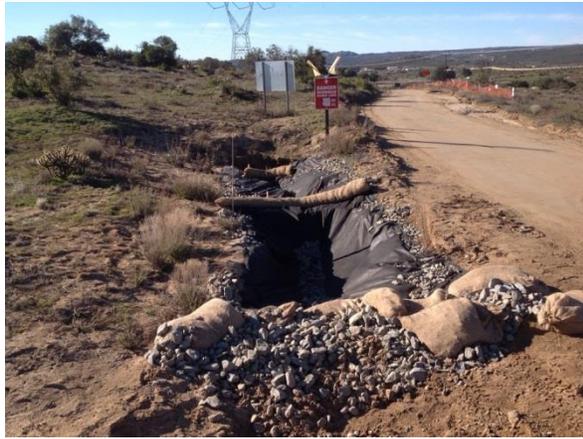
Since the reporting period starting on 12.19.16 (documented in the Weekly Report 14), SWPPP and third party compliance monitors have documented recurring failures of the installed erosion and sediment control devices due to the amount of precipitation that has occurred during rain events in December and January (approximately 12 inches). The recurring issues have been recorded as a “Problem Area” according to Section 5.2 of the ECCMP. To address this problem area, crews began installing rip-rap devices to replace failing straw wattles and damaged sand/gravel bags. Crews also began digging catch basins and drainage channels to manage the unanticipated amount of sediment generated during the rain events so far this season.

**Photo 1:** Crews began installing catch basins and rip-rap sediment and erosion control devices to replace damaged and failing straw wattles and sand/gravel bags in accordance with MM HYD-1 and the SWPPP. Photo shows a completed catch basin along McCain Valley Road where sediment was previously documented leaving the project site during SWPPP inspections.

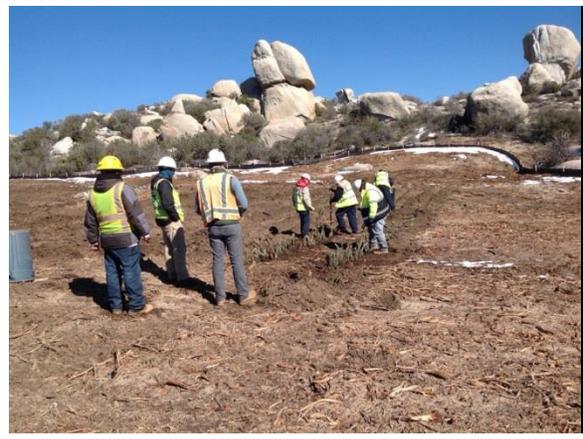
**Photo 2:** ECMs observed cultural and biological monitors/Habitat Restoration Specialists monitoring the planting of salvaged cacti at the E-String laydown area in accordance with MM CUL-1D and BIO-1C.

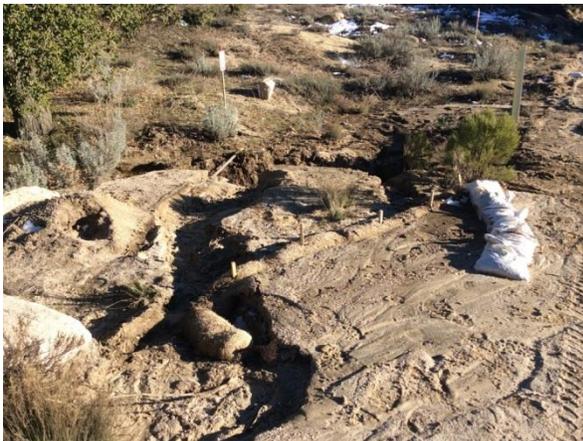
ECMs and SWPPP monitors inspected erosion and sediment control devices including straw wattles, silt fencing, sandbags, check dams, and culverts along McCain Valley Road. Some devices were found to be ineffective at preventing sediment discharge from the site and were in need of maintenance or repair. These issues were documented and reported to Tule Wind, LLC. During this reporting period, Tule Wind, LLC had construction crews onsite on a daily basis repairing, maintaining, and installing erosion and sediment control devices per direction provided by the Qualified SWPPP Practitioner (QSP) and third party ECMs in accordance with MM-HYD-1 and the project specific SWPPP.

**Photo 3:** ECMs and SWPPP inspectors checked the project site for areas where erosion and sediment control devices were missing or failing. These issues were documented and reported to Tule Wind, LLC. During this reporting period, construction crews were onsite daily to repair, maintain, and install additional erosion and sediment control devices in accordance with MM HYD-1 and the SWPPP.

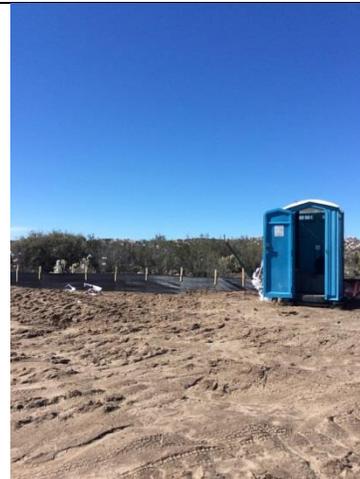
On Friday, January 27, 2017 the portable sanitation facility at the H-String laydown area had toilet paper blow into nearby vegetation during a period of high winds (gusts over 40 mph). ECMs notified the designated biologist and environmental lead. This issue has been recorded as a “Problem Area” according to Section 5.2 of the ECCMP. At the end of this reporting period, the resolution to this problem area was still in progress. Biological monitors are anticipated to sweep the area to clean up all remaining litter in accordance with MM BIO-7d.

**Photo 4:** On Friday, 1.27.17 ECMs observed toilet paper, which had blown out of the portable sanitation facility at the H-String laydown area into nearby vegetation during the windy conditions (gusts over 40 mph). This issue has been recorded as a "Problem Area" according to Section 5.2 of the ECCMP. Biological monitors are anticipated to sweep the area to clean up all remaining litter in accordance with MM BIO-7D.
