## BLM Authorized Officer Weekly Report

**Project:** Tule Wind Energy Project

### Weekly Project Update

**Reporting Period:** 1.2.17 through 1.8.17

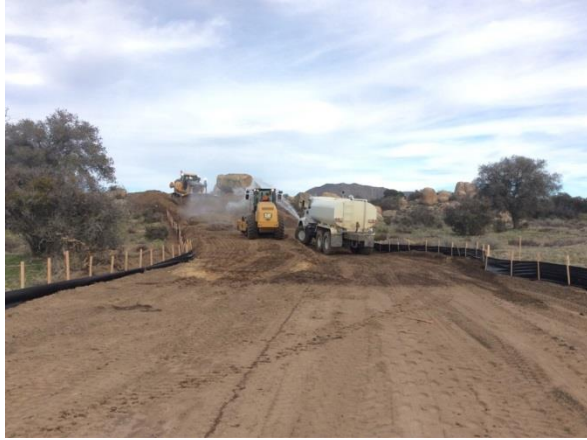
**Photo 1:** Clearing and grading activities observed within the staked limits of disturbance in accordance with MM BIO-1A. Water trucks in use for dust control in accordance with MM-AQ-1.

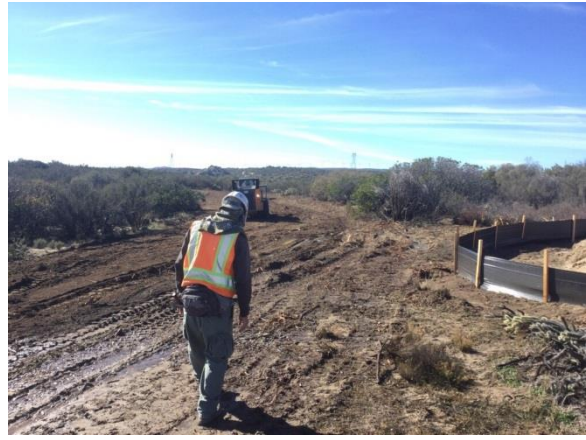
**Photo 2:** Cultural monitor observing clearing activities in accordance with MM CUL-1D.

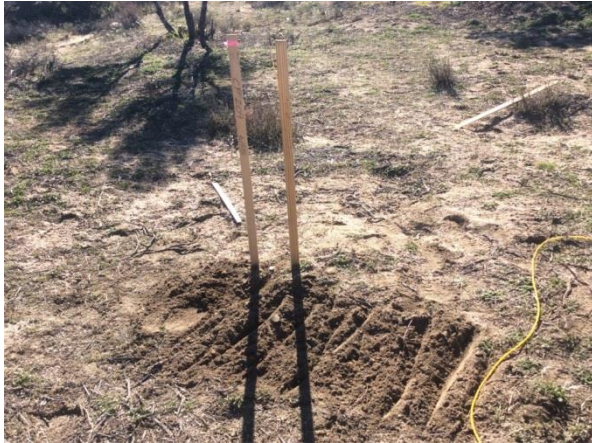
On Friday, January 6, 2017 a portable sanitation facility, which was previously secured using rope, was discovered overturned on the west side of McCain Valley Road. ECMs observed fluid discharge from the overturned facility. The stained soil was contained and removed from the site in accordance with Section 8.3 of the Hazardous Materials Management Plan. The facility was righted and secured. Tule Wind LLC is working to determine a permanent solution to securing the portable sanitation facilities onsite.

**Photo 3:** Spill from overturned portable sanitation facility cleaned and stained soil removed in accordance with Section 8.3 of the Hazardous Materials Management Plan. Tule Wind LLC is working to determine a permanent solution to securing the portable sanitation facilities onsite.

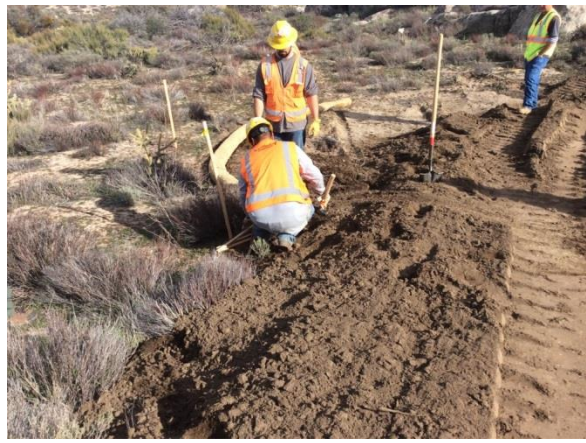
ECMs observed the installation, reinforcement, and repair of erosion and sediment control devices including straw wattles, silt fencing, and sandbags. Traffic along McCain Valley Road has begun to damage sandbags that have been placed as temporary check dams. In addition, multiple straw wattles along McCain Valley Road were damaged due to recent rain events. The damaged sandbags and straw wattles were reported to Tule Wind, LLC. Dedicated construction crews are in the process of repairing, maintaining, and installing erosion and sediment control devices.

**Photo 4:** Crews installing additional straw wattles along McCain Valley Road in accordance with the SWPPP and MM HYD-1.
