BLM Authorized Officer Weekly Report

Project: Tule Wind Energy Project

Weekly Project Update

Reporting Period: 11.28.16 through 12.4.16

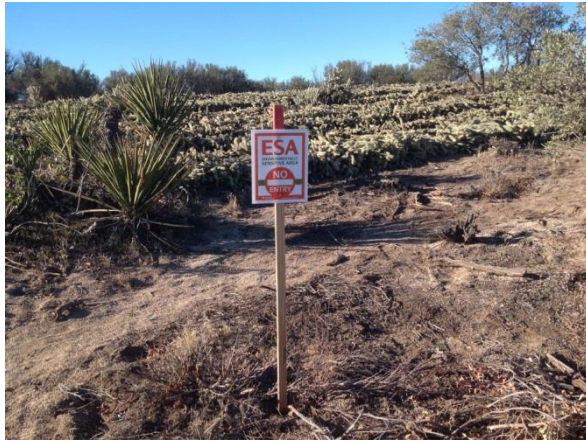
Cacti salvage activities concluded on 11.30.16 with the removal of cacti along the D String. The salvaged cacti are staged and marked with ESA signs within the project footprint near Structures E2 and G12 (and along the J String off of BLM-administered land). The cacti will be planted in designated areas in accordance with Section 5.2.2.1 of the Habitat Restoration Plan. All cacti salvage activities were observed within the temporary disturbance work limits in accordance with MM Bio-1a and occurred under the supervision of a Biological Monitor/Habitat Restoration Specialist in accordance with MM Bio-1c.

Photo 1: Salvaged cacti staged at laydown yard near Structure E2. ESA signs were installed to mark the area in accordance with Section 5.2.2.1 of the Habitat Restoration Plan (MM BIO-1D).

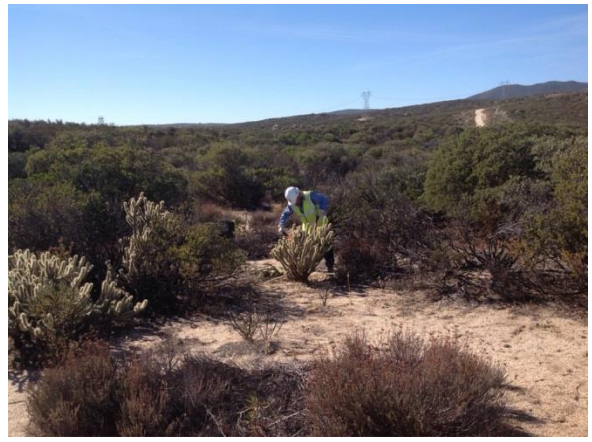
Photo 2: Cacti being salvaged along the D String using hand tools in accordance with Section 5.2.2.1 of the Habitat Restoration Plan (MM BIO-1D).

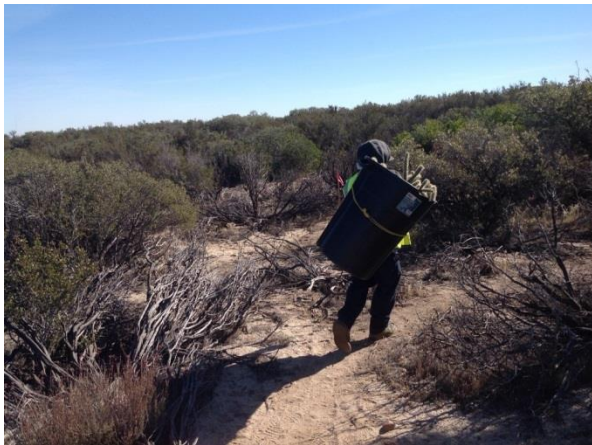
Photo 3: Salvaged cacti being hauled on foot to the BLM access roads before being driven along existing roads to the staging area near Structure E2, in accordance with the conditions of LNTP-2.

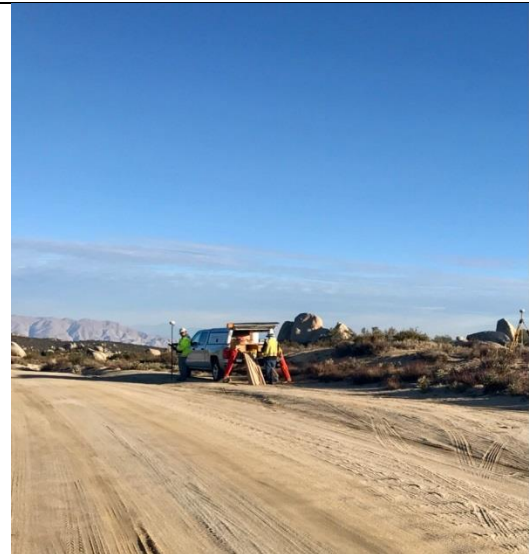
ECMs observed required fire equipment and best management practices on the project site during preconstruction activities, including vehicles with required fire suppression equipment and vehicles parked in areas with no vegetation. ECMs ensured crews were made aware of the requirements for having 3A, 40BC fire extinguishers, 5- gallon backpack pumps, and shovels.

Photo 4: Vehicles were observed parked in non-vegetated areas within the construction limits in accordance with the Construction Fire Prevention/Protection Plan (MM FF-1 and MM BIO-1F).
