BLM Authorized Officer Weekly Report

Project: Tule Wind Energy Project

Weekly Project Update

Reporting Period: 2.6.17 through 2.12.17

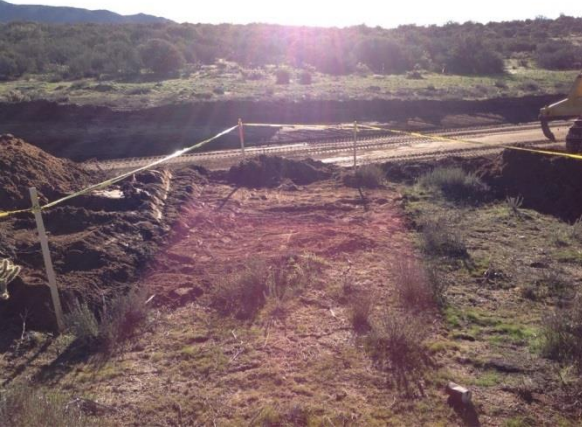
On February 9, 2017, ECMs observed a noncompliance event where an equipment operator caused disturbance beyond the limits of disturbance during grading activities along McCain Valley Road, on lands administered by the BLM. The operator inadvertently pushed soil outside the

limits of disturbance at a location where the limits of disturbance jut out towards the center line of the road. One of the limits of disturbance stakes was missing and the operator could not see the stake that was missing. Soil that was in front of the blade was pushed past the limits of disturbance and then pushed back into the limits of disturbance. As a result of this occurrence, contractors will review the grading plans ahead of time to identify areas of concern prior to grading activities due to irregular (non-linear) staking. The contractor will then have personnel identify these irregular disturbance limit boundaries in the field with GPS. Additional staking will be added or steel posts, with PVC extensions, will be installed where needed to give the operators greater visibility of limit of disturbance markers. In these irregular areas, the grading operators will walk the boundary prior to grading to make sure that they clearly understand the limits of disturbance.

Photo 1: On February 9, 2017, ECMs observed a noncompliance event where an equipment operator caused disturbance beyond the limits of disturbance by first pushing soil outside the limit and then back-dragging the soil back into the limits of disturbance.

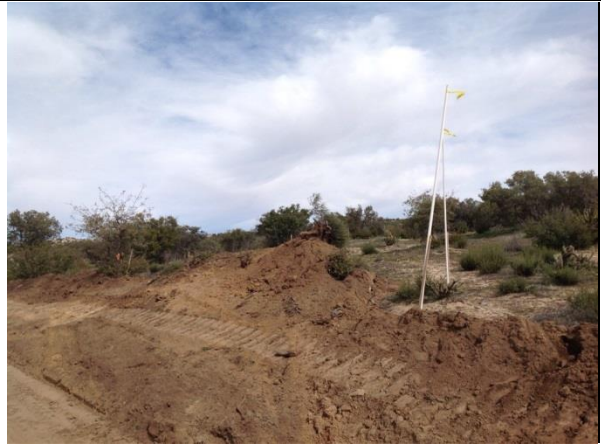
Photo 2: Contractor personnel added steel posts and PVC extensions where needed to give equipment operators greater visibility of limit of disturbance markers in response to the noncompliance event on February 9, 2017 (described in the caption of Photo 1).

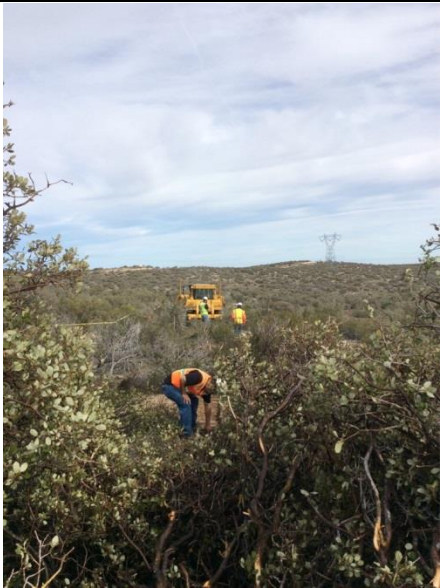
Photo 3: Resource monitors and equipment operators cut pre-grubbing lines in thick vegetation along the yellow tape disturbance limits with monitors acting as spotters ahead of the equipment in accordance with the February 1, 2017 NTP.

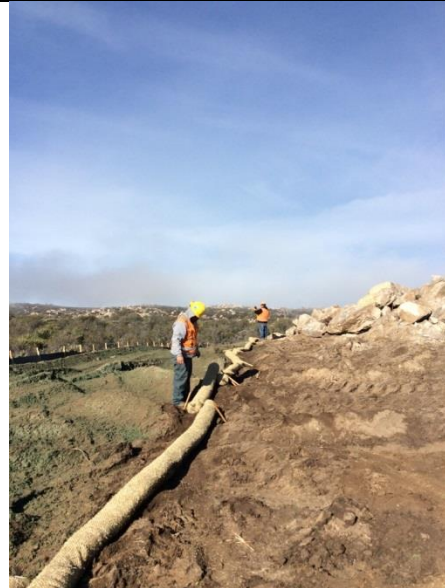
Photo 4: Crews observed installing erosion and sediment control devices around salvaged topsoil stockpiles in accordance with the Habitat Restoration Plan and Section 7.8 of the SWPPP.
