## **BLM Authorized Officer Weekly Report**

**Project:** Tule Wind Energy Project

### **Weekly Project Update**

**Reporting Period:** 2.20.17 through 2.26.17

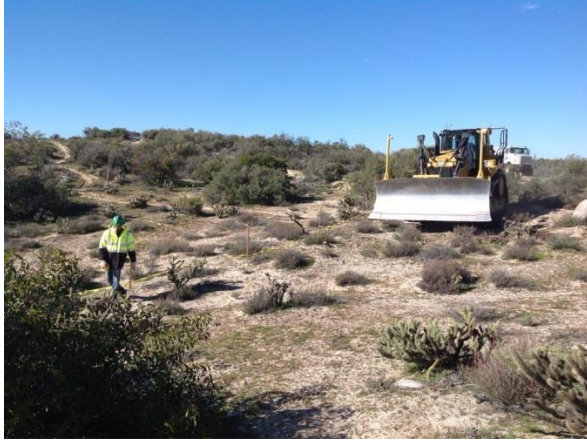
**Photo 1:** Spotters walked ahead of bulldozer operators who cleared large vegetation along the taped disturbance limits ahead of grubbing activities to help increase visibility for masticator operators in accordance with the February 1, 2017 NTP.

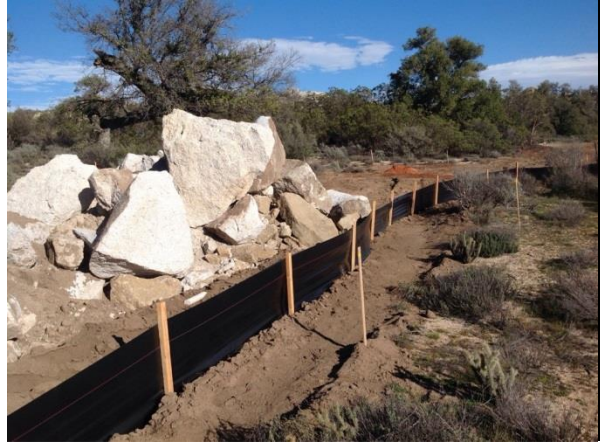
ECMs and SWPPP monitors inspected erosion and sediment control devices including straw wattles, silt fencing, sandbags, check dams, and culverts along McCain Valley Road. Most were in good condition, however, some devices were found to be damaged or ineffective at preventing sediment discharge from the site and were in need of maintenance or repair. These issues were documented and reported to Tule Wind, LLC. During this reporting period, Tule Wind, LLC had construction crews onsite to repair, maintain, and install erosion and sediment control devices per direction provided by the Qualified SWPPP Practitioner (QSP) and third party ECMs in accordance with MM-HYD-1 and the project specific SWPPP.

**Photo 2:** During this reporting period, crews repaired a damaged silt fence on the McCain Valley cutoff road per direction provided by the QSP and ECMs in accordance with the SWPPP.

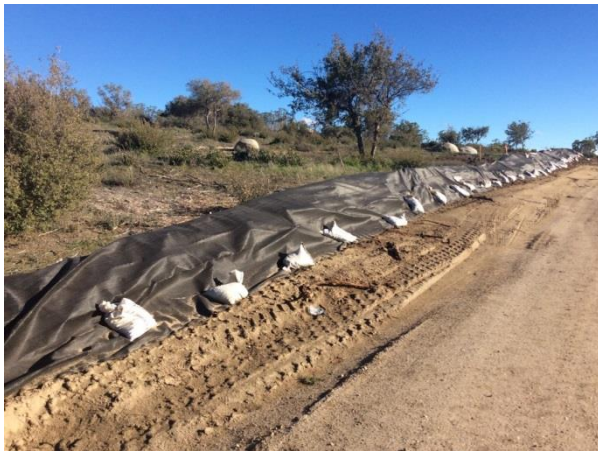
During this reporting period, ECMs observed the stockpiling of salvaged topsoil along the G-String. While topsoil salvage activities continue along the G-String, these stockpiles are still considered active. In accordance with Section 7.8 of the SWPPP, ECMs observed topsoil stockpiles which had been stabilized using hydromulch and wattles as well as windrows of topsoil covered with fabric secured with sandbags. Some of the fabric protecting windrow stockpiles was observed to be pulling away from the topsoil on February 23, 2017. These issues were discussed with the contractor to ensure inactive topsoil stockpiles continue to be protected during construction activities according to the SWPPP.

**Photo 3:** ECMs observed windrowed topsoil salvage stockpiles along McCain Valley Road covered in fabric secured with sand bags in accordance with the SWPPP.

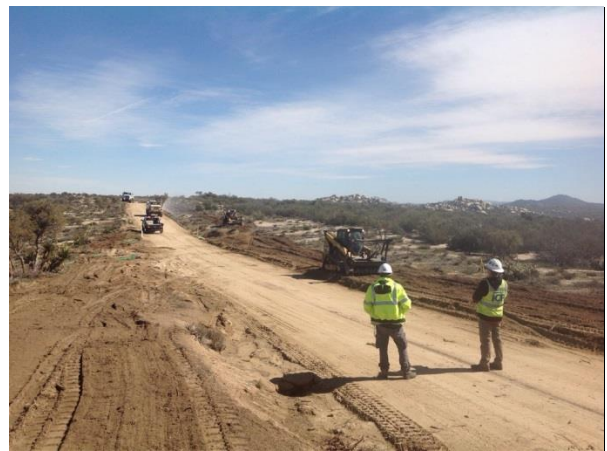
**Photo 4:** Biological, archaeological, and Native American monitors were present during road widening activities along McCain Valley Road in accordance with MM CUL-1D and BIO-1C. Water was applied regularly to reduce dust in accordance with the Dust Control Plan and MM AQ-1.
