BLM Authorized Officer Weekly Report

Project: Tule Wind Energy Project

Weekly Project Update

Reporting Period: 1.30.17 through 2.5.17

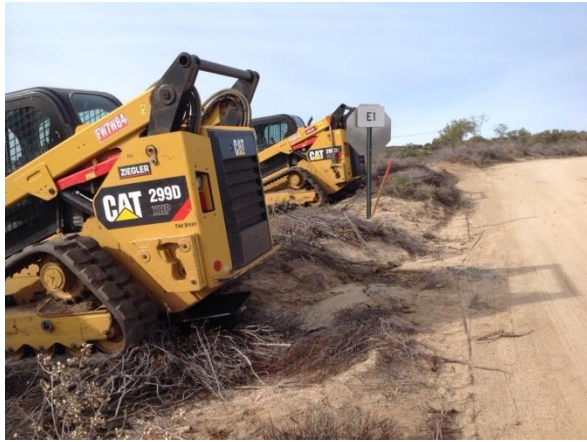
During this reporting period ECMs observed the placement of drip pans under equipment not in use in accordance with the containment and spill prevention procedures outlined in the Hazardous Materials Management Plan, MM HAZ-1a.

Photo 1: ECMs observed containment drip pans under parked equipment to prevent potential leaking equipment from staining soils in accordance with MM HAZ-1A and the Hazardous Materials Management Plan.

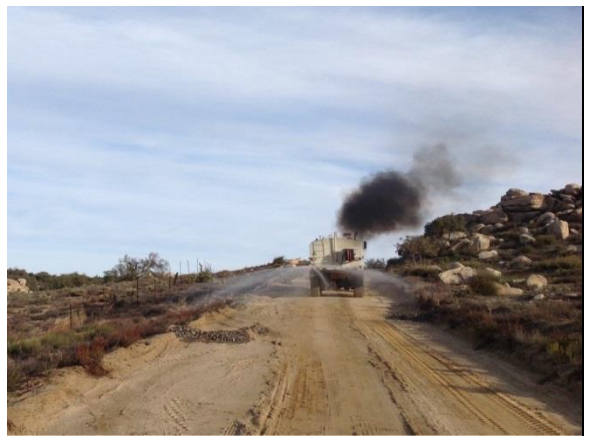
During this reporting period, ECMs observed a water truck producing visible, dark emissions on three separate days. ECMs contacted Tule Wind, LLC about this issue and the truck was removed from the site on February 3, 2017.

Photo 2: ECMs observed a water truck producing visible, dark emissions on several occasions during this reporting period. The truck was removed from the project site on February 3, 2017.

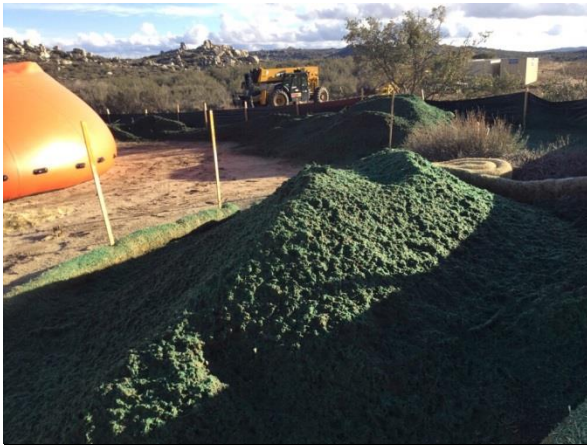
Photo 3: Hydromulch was applied to salvaged topsoil storage piles to prevent erosion in accordance with MM HYD-1 and the SWPPP.

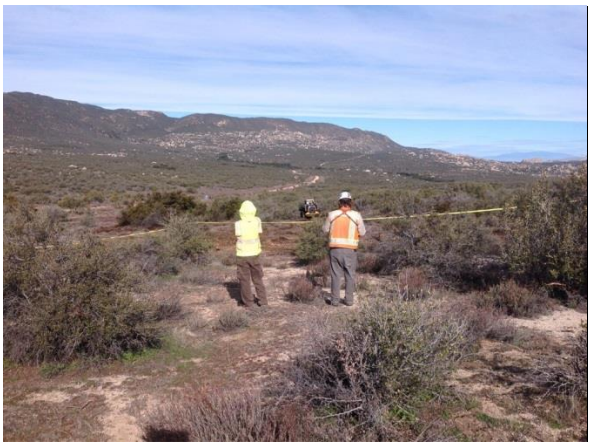
Photo 4: Biological monitors were present to observe grubbing activities in accordance with MM BIO-1C. All observed activities occurred within the disturbance limits in accordance with MM BIO-1A. Yellow tape was strung between disturbance limit stakes to increase visibility of limits for masticator operators in accordance with the NTP issued on February 1, 2017.
