BLM Authorized Officer Weekly Report

Project: Tule Wind Energy Project

Weekly Project Update

Reporting Period: 3.13.17 through 3.19.17

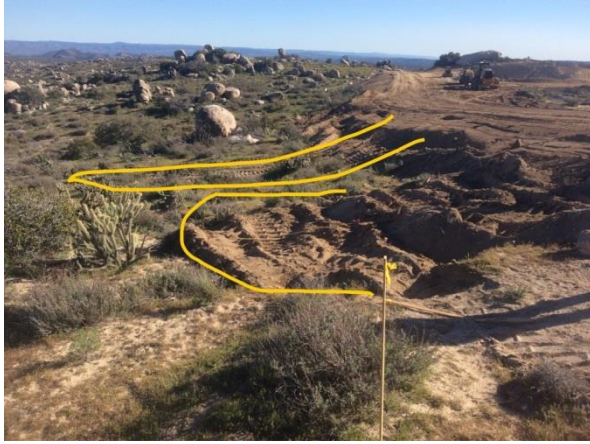
- During grading activities, a blade hit a rock located below the ground surface along the access road north of turbine pad G8. When the blade hit the rock, it lost balance and travelled outside of the approved limits of disturbance while trying to regain balance. An approximately 40-foot by 10-foot area was disturbed outside of the approved limits of disturbance. Per ECM's conversations with the equipment operator, if the equipment had not travelled outside of the approved limits of disturbance to regain balance, the blade could have tipped over.
- A D8 bulldozer slipped down the slope of turbine pad G6 during grading activities. The bulldozer did not cross the limits of disturbance, but dirt extending approximately 100 square feet was pushed outside of the limits of disturbance.

In each case, archaeological and Native American monitors were present at the time of the incident and the area had been swept by a biological monitor. The areas of disturbance were inspected and it was determined that no damage to sensitive environmental resources occurred.

Photo 1: On March 13, 2017, disturbance beyond the staked limits of disturbance occurred when a piece of construction equipment hit a subsurface rock and lost control. The area of disturbance was inspected and it was determined that no damage to sensitive environmental resources occurred.

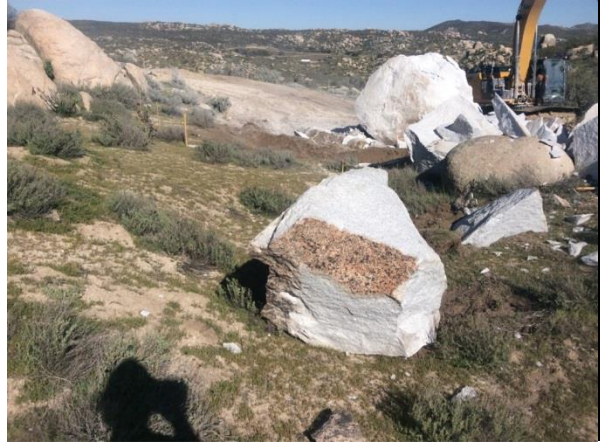
During blasting activities on March 16, 2017, rock debris fell outside the disturbance limits near the turbine pad G15. The pieces of rock were recorded and left in place to avoid creating additional unauthorized disturbance.

Photo 2: During blasting activities on March 16, 2017, rock debris fell approximately 10 feet outside the staked disturbance limits. The pieces of rock were left in place to avoid creating additional unauthorized disturbance.

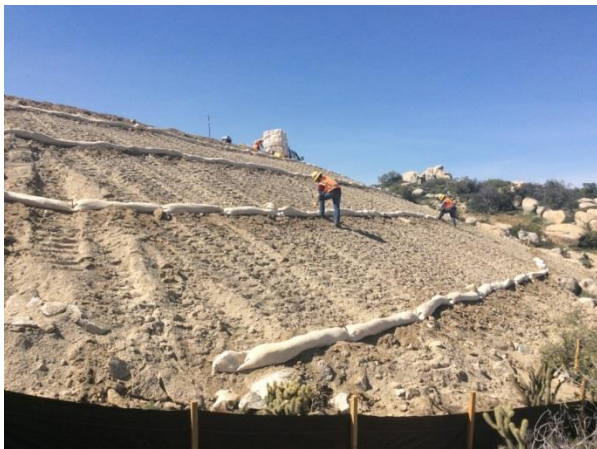
Per direction from the BLM, California Department of Fish and Wildlife (CDFW), and the California State Water Resources Control Board, Tule Wind, LLC has ceased the use of all plastic encased straw wattles. During this reporting period, Tule Wind, LLC had construction crews onsite to install biodegradable and weed-free straw wattles. Tule Wind, LLC is replacing the existing plastic encased straw wattles that have previously been installed. The removed plastic encased wattles are being hauled off site for disposal.

Photo 3: ECMs observed construction crews installing biodegradable and weed-free straw wattles at the H1 turbine pad in accordance with the SWPPP and per direction from the BLM, CDFW, and State Water Board.

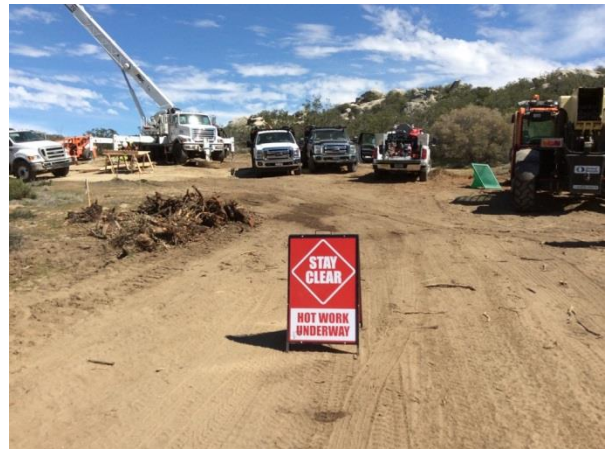
Hot work permits were issued for tower foundation work and ECMs verified that the Fire Safety Coordinator as well as Fire Watch personnel were present to monitor the hot work activities. Proper equipment was also present and warning signs were posted at the work site in accordance with the hot work permit and MM FF-1. Fire Watch personnel remained at the work site with required equipment for an hour after the work was completed.

Photo 4: Required equipment and warning signs were present at the Transmission Line Pole 4 during hot work activities in accordance with the issued hot work permit and the Fire Prevention/Protection Plan (MM FF-1).
