BLM Authorized Officer Weekly Report

Project: Tule Wind Energy Project

Weekly Project Update

Reporting Period: 2.27.17 through 3.5.17

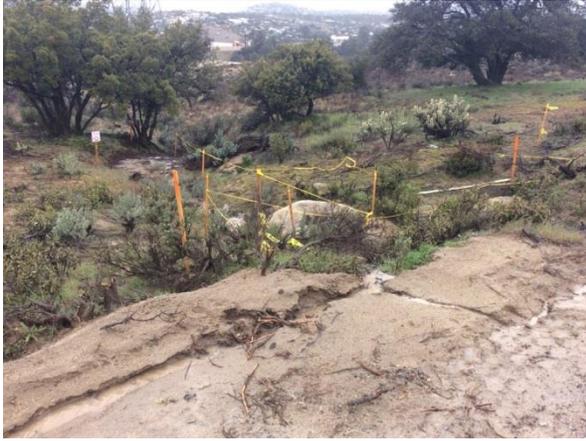
ECMs and SWPPP monitors inspected erosion and sediment control devices including straw wattles, silt fencing, sandbags, check dams, and culverts along McCain Valley Road. Most were in good condition, however, some areas where recent grading activities had occurred required additional BMP installations to prevent sediment from leaving the ROW. These issues were documented and reported to Tule Wind, LLC. During this reporting period, Tule Wind, LLC had construction crews onsite to repair, maintain, and install erosion and sediment control devices per direction provided by the Qualified SWPPP Practitioner (QSP) and third party ECMs in accordance with MM-HYD-1 and the project specific SWPPP.

Photo 1: ECMs and SWPPP monitors observed and reported locations along McCain Valley Road where recent grading activities changed the path of overland flow and additional BMPs are required to ensure sediment remains on the ROW. Tule Wind, LLC had BMP installation and maintenance crews onsite to resolve these issues during this reporting period.

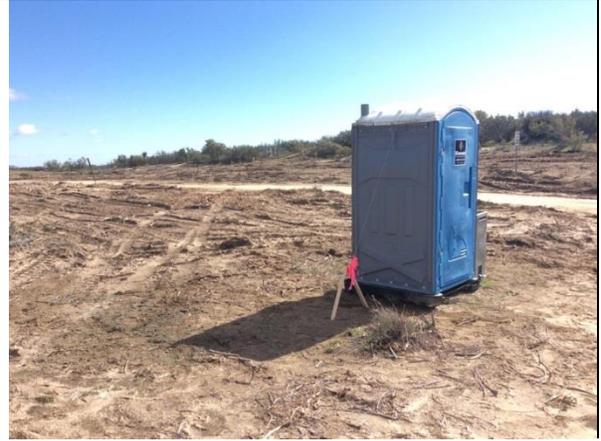
On Monday, February 27, 2017, a third party ECM reported a portable restroom facility that had blown over along the D-String during a period of high winds. The portable restroom was staked down. The following day, the portable restroom was turned upright and re-staked to prevent the issue from reoccurring. Stained soil from the overturned portable restroom was removed in accordance with the Hazardous Materials Management Plan.

Photo 2: The portable restroom which had blown over during a period of high winds on February 27, 2017 was turned upright and staked the following day to prevent the issue from reoccurring. The stained soil was removed in accordance with MM HAZ-1A.

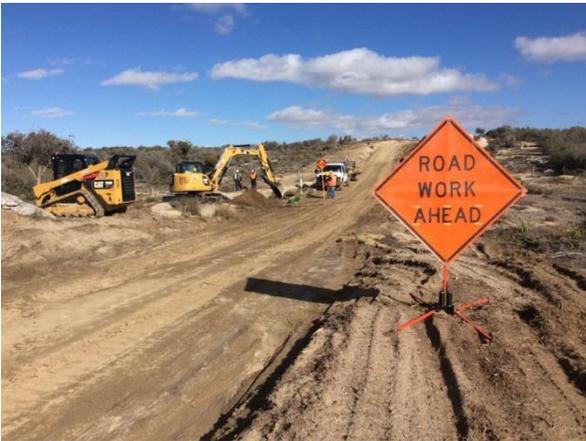
Photo 3: Traffic control flaggers and signs were present to notify motorists of work areas while crews worked along McCain Valley Road in accordance with the Traffic Control Plan (MM TRA-1).

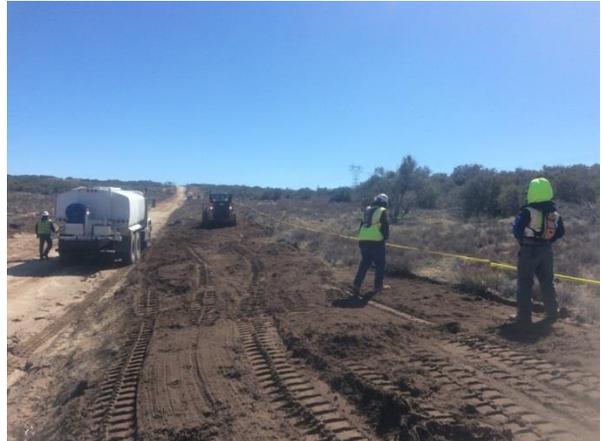
Photo 4: Archaeological and Native American monitors were present during road widening activities along McCain Valley Road in accordance with MM CUL-1D. Water was applied regularly to reduce dust in accordance with the Dust Control Plan and MM AQ-1 and disturbance limits were demarcated with yellow tape in accordance with the February 1, 2017 NTP.
