BLM Authorized Officer Weekly Report

Project: Tule Wind Energy Project

Weekly Project Update

Reporting Period: 4.17.17 through 4.23.17

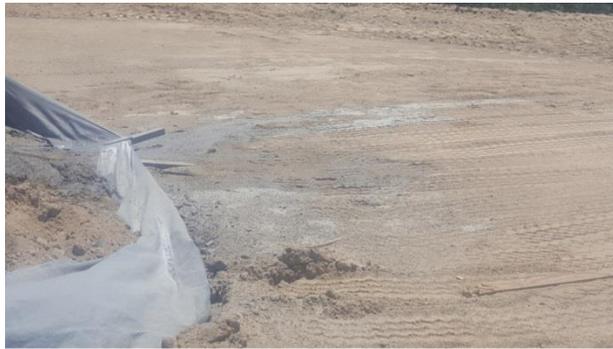
On April 21, 2017, ECMs recorded a silt fence that had fallen down and concrete wash runoff surrounding the concrete washout basin at turbine site E11. The DB was notified of the incident and ECMs confirmed that the silt fence had been repaired in accordance with Section 7.10 of the SWPPP and the concrete wash surrounding the basin had been cleaned.

Photo 1: On April 21, 2017, ECMs recorded a downed silt fence and concrete wash runoff surrounding the concrete washout basin at turbine site E11. The DB was notified of the incident.

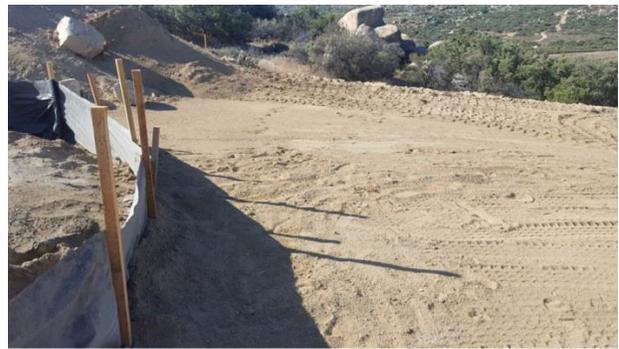
Photo 2: On April 22, ECMs confirmed that the silt fence surrounding the concrete washout basin had been repaired in accordance with Section 7.10 of the SWPPP and the concrete wash outside the basin containment had been cleaned.

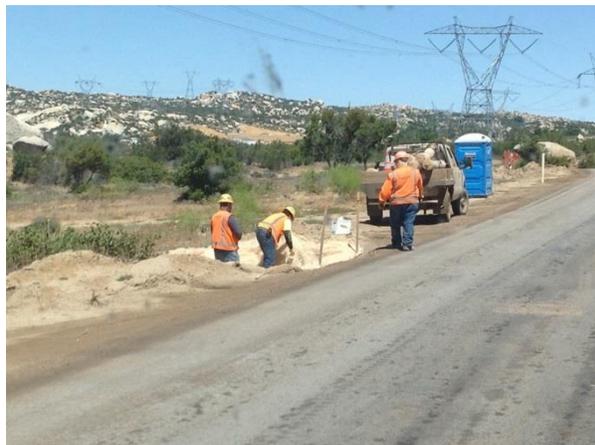
Photo 3: Erosion control devices were installed at culverts along McCain Valley Road in accordance with the project SWPPP.

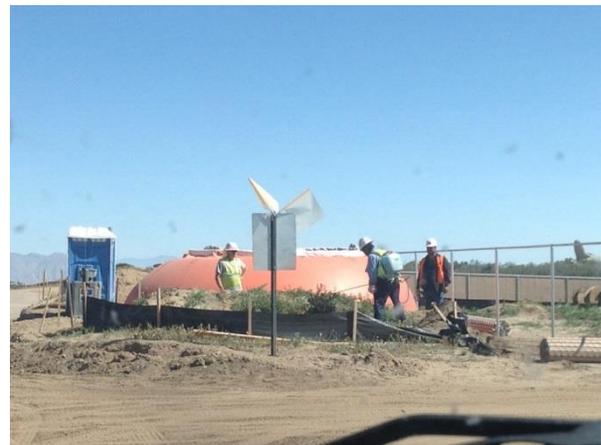
Photo 4: During this reporting period, herbicide was applied along the E String by a QAL holder and under the supervision of a Habitat Restoration Specialist, in accordance with Section 6.1.2 of the Habitat Restoration Plan.
