BLM Authorized Officer Weekly Report

Project: Tule Wind Energy Project

Weekly Project Update

Reporting Period: 05.29.17 through 06.04.17

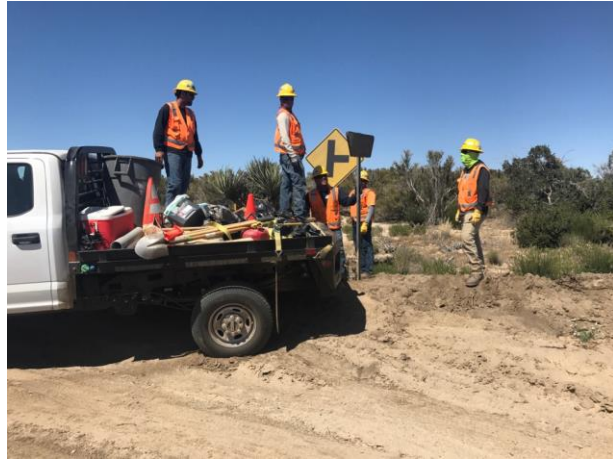
As discussed during the previous reporting period, ECMs observed several traffic signs knocked over along McCain Valley Road and at the entrances to the B and H lines. On 06/01/2017, ECMs observed construction crews replacing and re-installing signs accordance with MM-TRA-1.

Photo 1: ECMs observed construction crews replace and re-install traffic signs along McCain Valley Road per MM-TRA-1.

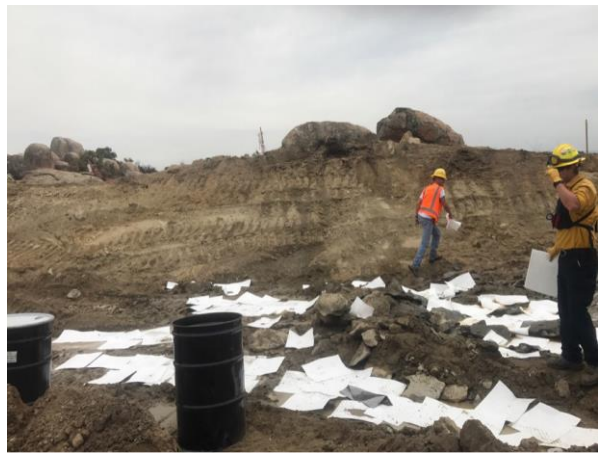
On 05/31/2017 ECMs observed an excavator with a malfunctioning hydraulic line leak fluid during rock breaking activities along a connector road. The leak was contained and all stained soil and

absorbent materials used to clean the leak were collected in large drums to be properly disposed of in accordance with the Hazmat Management Plan per MM-HAZ-1A.

Photo 2: Construction crews are observed using absorbent materials to address a hydraulic leak per the Hazardous Materials Management Plan and MM-HAZ-1A.

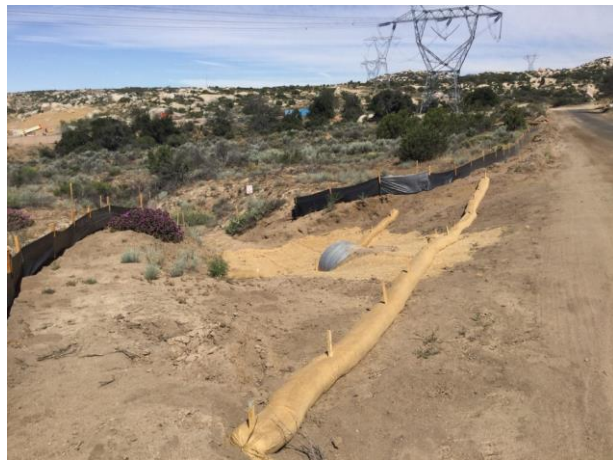
Photo 3: Erosion blankets and biodegradable straw wattles are installed along culverts in accordance with MM-HYD-4 and site specific SWPPP.

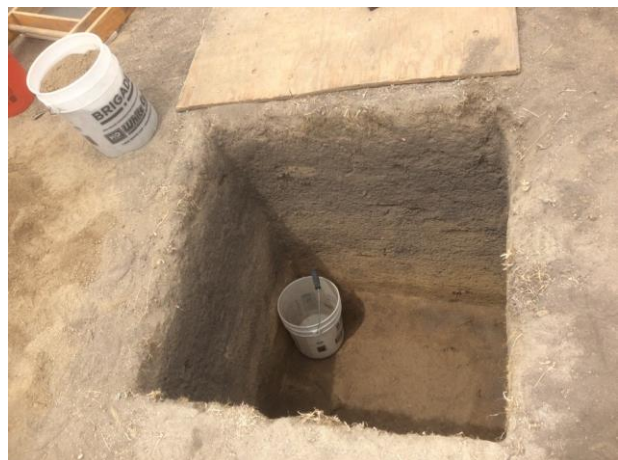
On Tuesday, 05/30/2017, Archaeological monitors completed excavation of 50 shovel test pits and continued phase II data recovery efforts at archaeological site CA-SDI-17,817 in accordance with the approved Treatment Plan dated 05/08/2017. Native American monitors were present to monitor and assist with the excavation of shovel test pits and phase II data recovery efforts.

Photo 4: Phase II data recovery efforts continued during this reporting period in accordance with the approved Treatment Plan dated May 8, 2017.
