BLM Authorized Officer Weekly Report

Project: Tule Wind Energy Project

Weekly Project Update

Reporting Period: 08.07.17 through 08.13.17

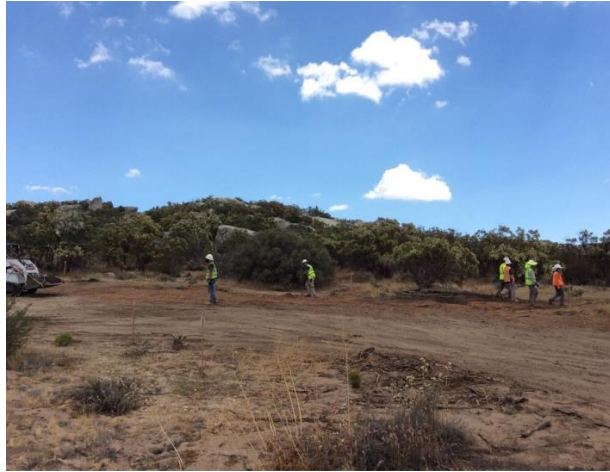
Photo 1: ECMs observed biological and cultural monitors conducting sweeps ahead of a skid steer during electrical line pulling for transmission pole 4, in accordance with MM-CUL-1d.

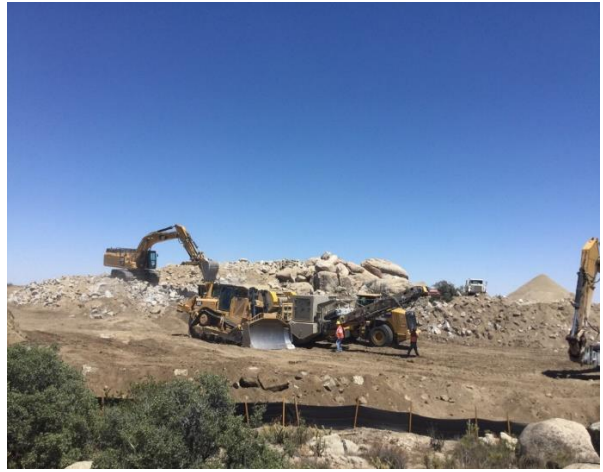
Photo 2: ECMs observed rock management at laydown yard #10, with water tender present in the background in accordance with MM-AQ-1 and MM-FF-1.

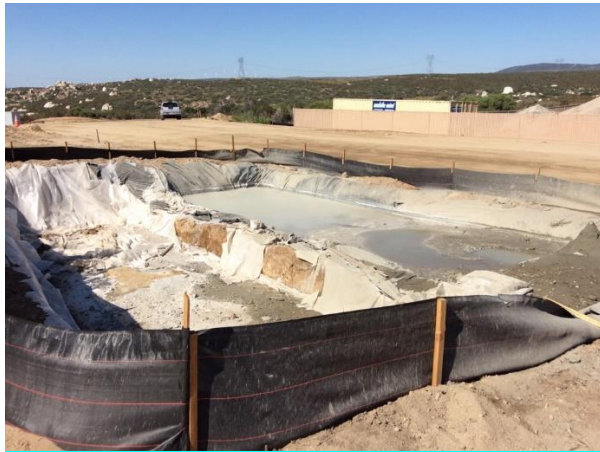
During this reporting period, several areas were identified with deficient silt fencing. In addition, the plastic lining in the concrete washout basins in laydown yard #6 were in need of repair. The designated biologist and construction contractor were notified of the issues.

Photo 3: ECMs observed torn plastic liner, a damaged silt fence, and one side full of concrete residue at a concrete washout basin in laydown yard #6.

On Friday, 8/11/17, ECMs observed construction crews conducting ongoing repairs to silt fences and concrete washout basins in laydown yard # 6, concrete washout basin at turbine site C-9, and installing straw wattles at turbine site C-5. ECMs will continue to monitor and report potential issues to ensure that they are addressed in a timely manner.

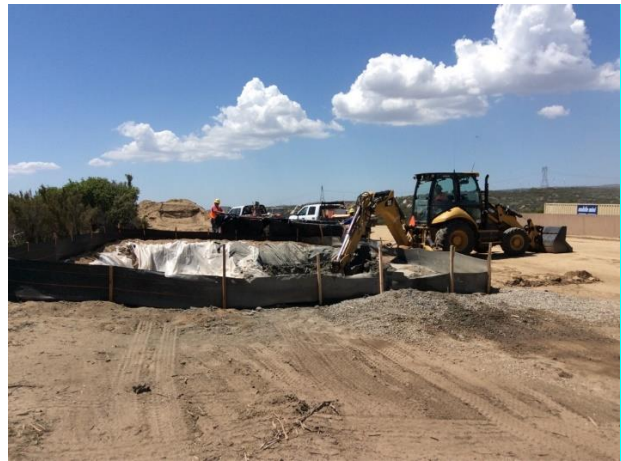
Photo 4: ECMs observed construction crews cleaning out the concrete washout basin and repairing the silt fence shortly after the construction superintendent was notified, in accordance with the site specific SWPPP.
