BLM Authorized Officer Weekly Report

Project: Tule Wind Energy Project

Weekly Project Update

Reporting Period: 08.28.17 through 09.03.17

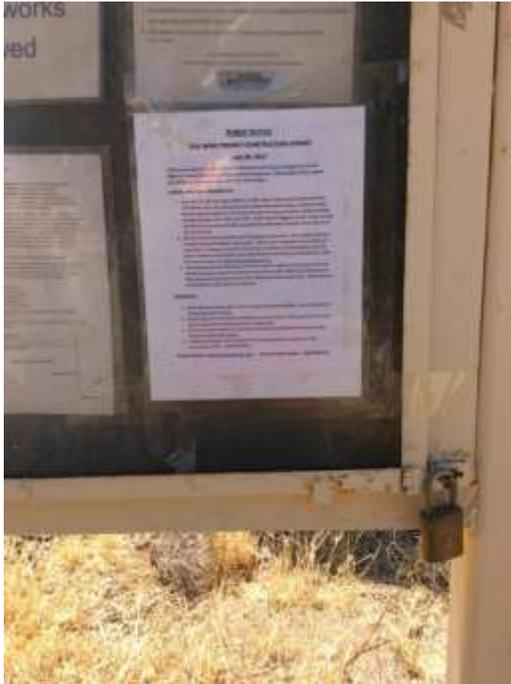
Photo 1: During this reporting period, ECMs observed a public notice sign in Lower Lark Canyon Campground, providing notice of anticipated delays/closures in and around the wilderness and recreation area in accordance with MM-WR-1.

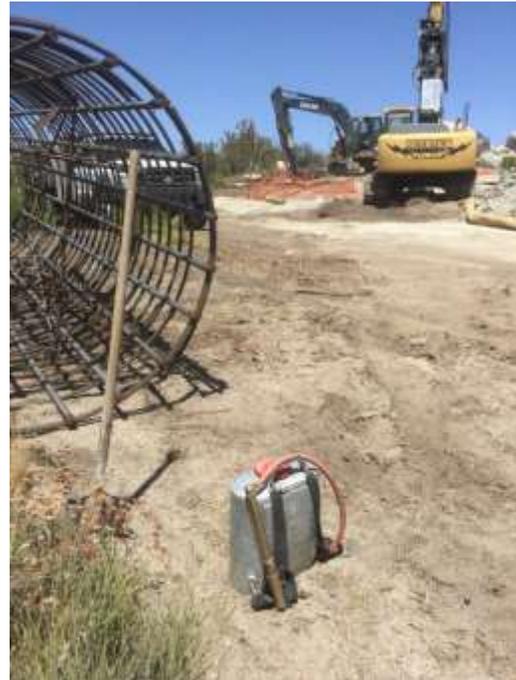
Photo 2: ECMs observed fire tools and water truck (not pictured) on site during drilling activities in accordance with MM-FF-1.

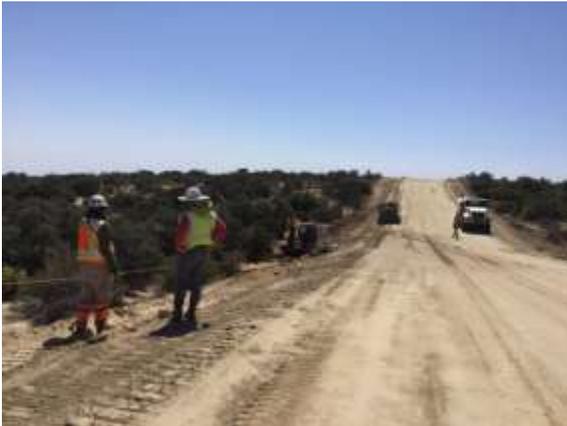
Photo 3: ECMs observed cultural and biological monitors present during excavation for rip rap installation on the C-line in accordance with MM-BIO-1a and MM-CUL-1d.

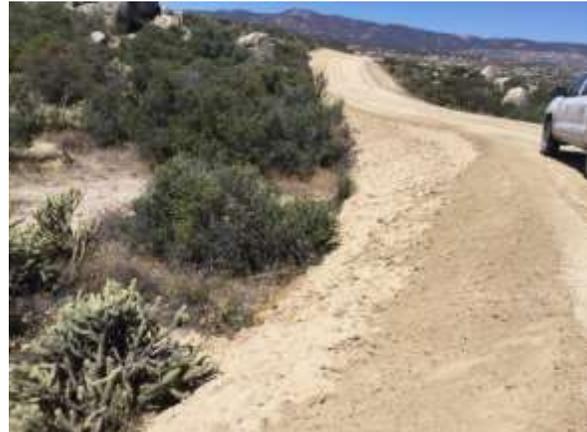
During this reporting period, ECMs observed construction crews conducting ongoing repairs to silt fences and straw wattle erosion control devices. Multiple locations are in need of repairs, with each location communicated to the designated biologist. ECMs identified straw wattles submerged under soil on the D2-D4 access road, and inoperable silt fences on the A-line access road. ECMs continue to coordinate through the designated biologist for maintenance repair crews to repair deficient sections.

Photo 4: During this reporting period, ECMs notified the designated biologist of straw wattle submerged under soil on the D2-D4 access road. These BMPs are anticipated to be repaired during the next reporting period.
