## **BLM Authorized Officer Weekly Report**

**Project:** Tule Wind Energy Project

### **Weekly Project Update**

**Reporting Period:** 09.25.17 through 10.01.17

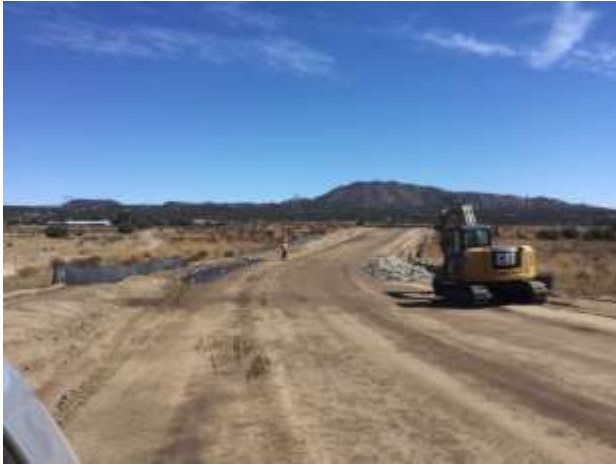
**Photo 1:** ECMs observed the installation of rip rap with cultural monitors present in accordance with MM CUL-1D.

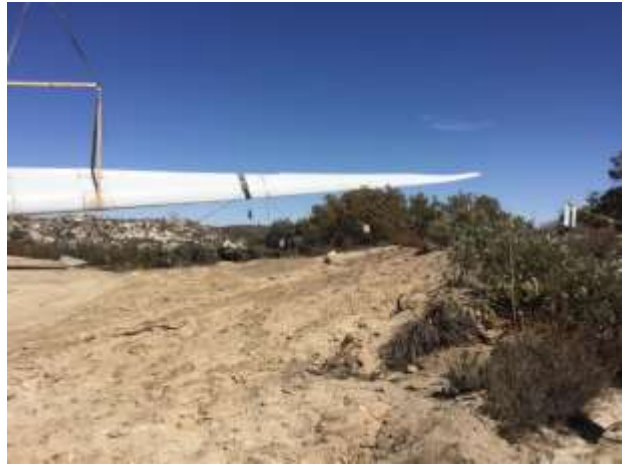
On 9/30/17, during blade installation at turbine pad G-14, a turbine blade and tag line extended outside the limits of disturbance. Before work was allowed to resume, the area was cleared per the protocols established by Variance Request 006 by biological and cultural monitors along with the ECM. The tag lines came into contact with vegetation approximately 20 feet outside the limits of disturbance boundary. No impacts to cultural or biological resources were observed.

**Photo 2:** ECMs observed turbine blade assembly at pad G-14. Blades extended approximately 65 feet outside the limits of disturbance. Before installation continued, the area was cleared per the protocols of Variance Request 006. The area was swept by biological and cultural monitors along with third party ECMs to ensure no biological or cultural resources were affected.

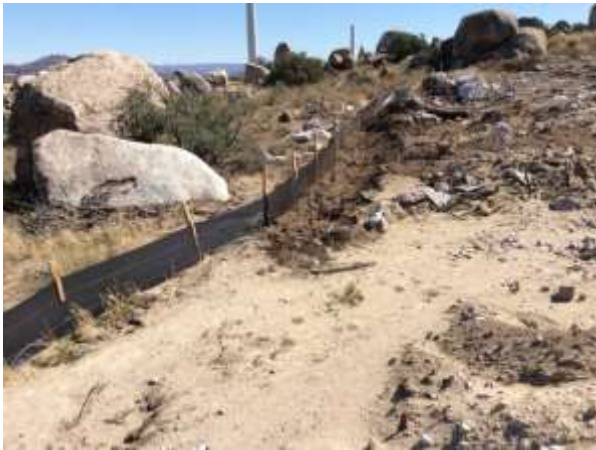
During the previous reporting period, silt fencing at turbine pad G-3 was in need of repair. During this reporting period, ECMs confirmed that the silt fence had been repaired.

**Photo 3:** ECMs observed a repaired silt fence from a previous reporting period, in accordance with the project SWPPP and MM HYD-1.

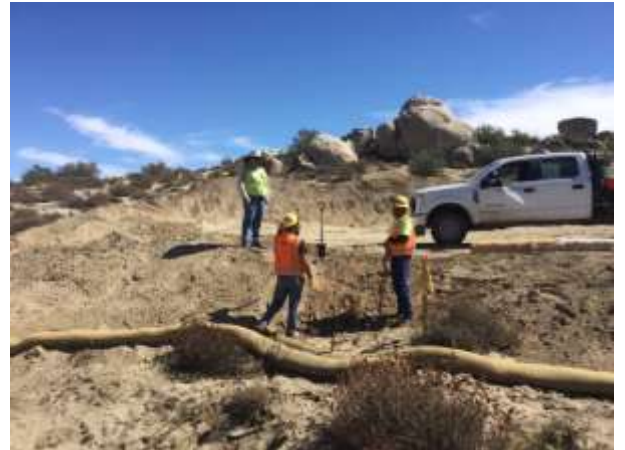
**Photo 4:** ECMs observed cultural and biological monitors present for erosion control maintenance and repairs in accordance with MM BIO-1D and MM CUL-1D.
