BLM Authorized Officer Weekly Report

Project: Tule Wind Energy Project

Weekly Project Update

Reporting Period: 11.13.17 through 11.19.17

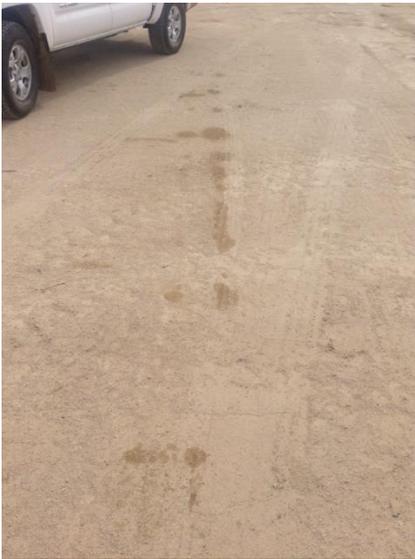
Photo 1: ECMs were present to observe construction crews clean and properly dispose of stained soil in accordance with MM HAZ-1.

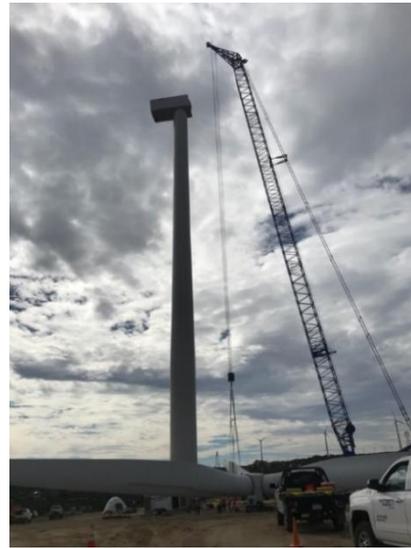
Photo 2: ECMs observed rotor assembly along the E-line. Archaeological and Native American monitors spot checked the activity in accordance with MM CUL-1D.

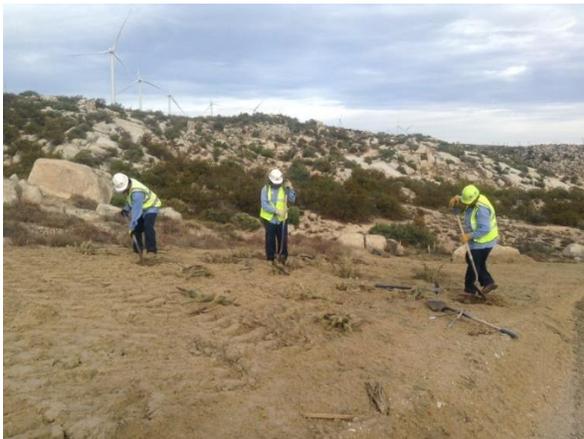
Photo 3: ECMs observed cactus replanting per MM BIO-1d and the Habitat Restoration Plan.

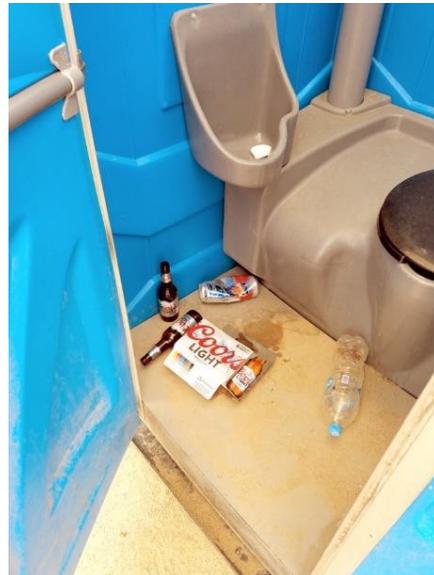
On 11/13/2017, an ECM discovered alcohol bottles and a water bottle inside the first portable toilet along the entrance to McCain Valley Road. The ECM contacted the designated biologist, to notify him of the location. The designated biologist stated that he would get clean the trash in accordance with MM BIO-7d. By the following day, an ECM checked this same location and confirmed that it had been cleaned up.

Photo 4: ECM discovered alcohol bottles and water bottle trash inside the first portable toilet along the entrance to McCain Valley Road. The trash was cleaned-up by the following day in accordance with MM BIO-7D.
