## **BLM Authorized Officer Weekly Report**

**Project:** Tule Wind Energy Project

### **Weekly Project Update**

**Reporting Period:** 12.5.16 through 12.11.16

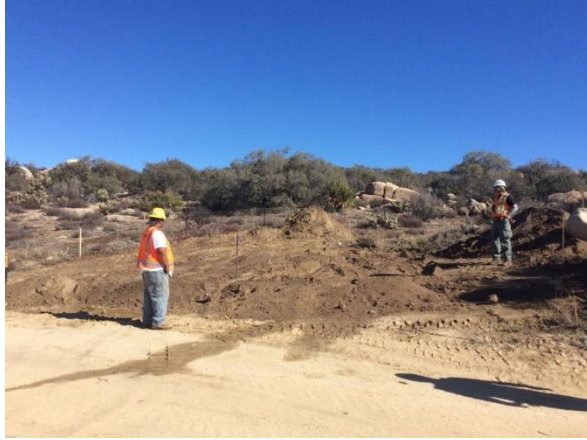
**Photo 1:** Archaeological and Native American monitors present during clearing and grading activities for the installation of water tanks along McCain Valley Road (MM-CUL-1d).

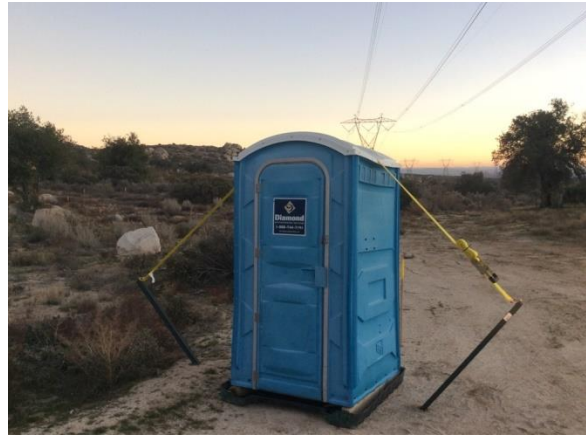
ECMs observed all portable restroom facilities to be staked to the ground surface with containment in place to prevent the potential for leaks or spills in accordance with ROW Grant Stipulation 78 and the Hazardous Materials Management Plan.

**Photo 2:** Portable restroom facilities are staked to the ground surface with containment in place to prevent the potential for leaks or spills in accordance with ROW Grant Stipulation 78 and the Hazardous Materials Management Plan.

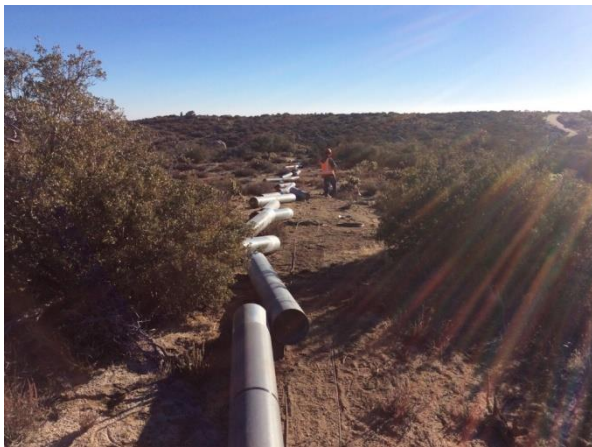
In addition to clearing and grading activities, three of the five temporary meteorological (met) towers were decommissioned and removed from the project site in accordance with the Meteorological Tower Decommissioning Plan. The met towers were initially installed under a ROW Grant issued by the BLM on September 15, 2004 (CACA-45248). The two remaining met towers are anticipated to be decommissioned and removed from the project site during the week of December 12<sup>th</sup>.

**Photo 3:** Three of the five temporary met towers were decommissioned and removed in accordance with the Met Tower Decommissioning Plan.

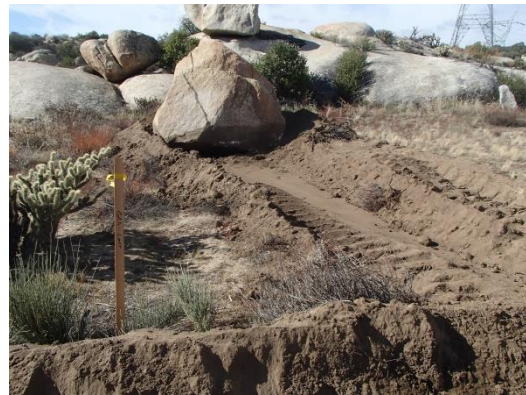
At approximately 1:30 pm, on 12.08.16 a biological monitor notified BLM's third-party ECM of a potential problem area. BLM's third-party ECM evaluated the problem area and observed a boulder that was pushed past the staked disturbance limits on the west side of the access road that leads to the 80-acre parcel, on lands administered by the BLM. The boulder was pushed approximately 15 feet past the staked limits of disturbance causing approximately 150 square feet of disturbance. BLM's third-party ECM and archaeological monitor inspected the area of disturbance and found no impacts to sensitive biological or cultural resources. In accordance with Section 5.2 of the ECCMP, this event is being classified as a "Problem Area" or "an activity that the compliance monitors determine is unintentional and an isolated departure from the project specifications, with no damage to resources". The BLM will be working with Tule Wind LLC to document the problem area and to take measures to prevent similar issues from occurring.

**Photo 4:** A boulder was pushed approximately 15 feet outside of the limits of disturbance. This event is being classified as a "Problem Area" in accordance with 5.2 of the ECCMP.
