BLM Authorized Officer Weekly Report

Project: Tule Wind Energy Project

Weekly Project Update

Reporting Period: 2.13.17 through 2.19.17

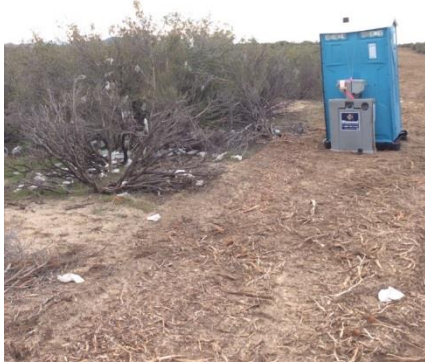
Photo 1: On February 14, 2017, the portable sanitation facility at the F-String access road had toilet paper blow into nearby vegetation during a period of high winds. ECMs notified the designated biologist and the litter was removed upon notification.

On February 14, 2017, the portable sanitation facility at the F-String access road had toilet paper blow into nearby vegetation during a period of high winds. ECMs notified the designated biologist and the litter was removed upon notification.

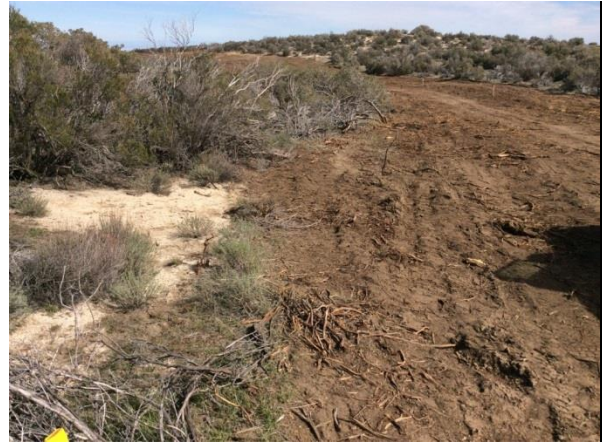
On February 14, 2017, the Dudek third party lead ECM along with a survey and engineering team verified a breach of the approved limits of disturbance along the C-String. During the event, a rubber tracked skid steer travelled approximately seven feet outside the staked limits of disturbance and travelled approximately 35 feet before re-entering the limits.

The lead ECM recorded that the skid steer was conducting clearing activities when it travelled along the staking tape that was bowed outside of the limits of disturbance by the wind. The skid steer operator followed the arc of the staking tape rather than travelling in a straight line between the stakes. The limit stakes were spaced approximately 100 feet apart from one another. The lead ECM and an archaeological monitor examined the disturbance area and determined that there were no impacts to sensitive biological or cultural resources. There were no environmentally sensitive areas (ESAs) in the vicinity of the unauthorized disturbance.

Photo 2: On February 9, 2017, a breach of the approved limits of disturbance along the C-String was observed.

Per discussions between the BLM and Tule Wind, LLC, to avoid similar events from reoccurring, Tule Wind, LLC will be installing staking at a maximum of 25-foot increments. For the areas that have already been staked at 100-foot increments, new stakes would be placed inbetween the stakes placed at 100 feet. No work is authorized to occur in any area until the additional stakes are placed in the area.

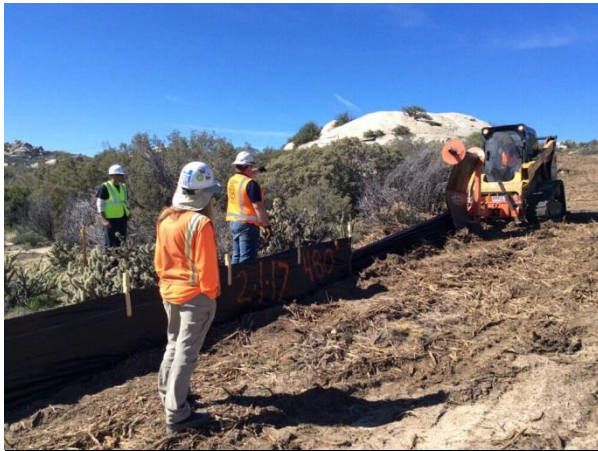
Photo 3: Archaeological and Native American monitors observed the installation of silt fence near site E13 in accordance with MMs CUL-1D and HYD-1.

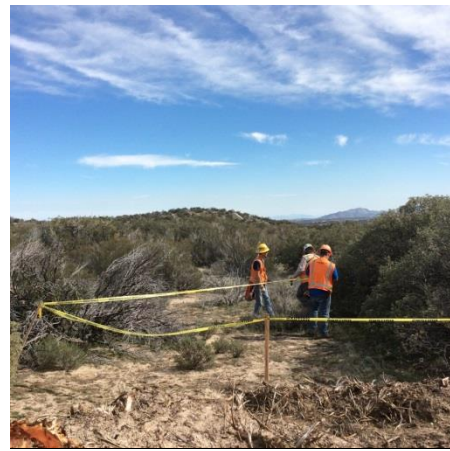
Photo 4: Crews observed verifying disturbance limit stake locations and installing yellow tape prior to the start of disturbance activities in accordance with the NTP issued February 1, 2017.

ECMs observed construction crew members walking disturbance limits prior to the start of ground disturbance activities to ensure limits were staked correctly. Crews installed additional staking or steel posts with PVC extensions where needed to give the operators greater visibility of limit of disturbance markers. In addition, yellow tape was strung between disturbance limit stakes to enhance visibility of the limits for equipment operators, spotters, and monitors in accordance with the NTP issued February 1, 2017.
