BLM Authorized Officer Weekly Report

Project: Tule Wind Energy Project

Weekly Project Update

Reporting Period: 3.6.17 through 3.12.17

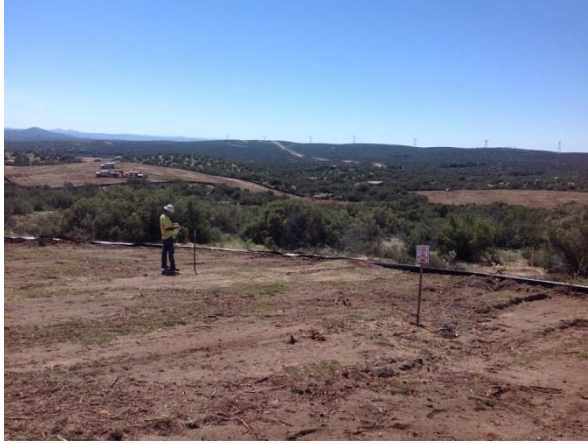
Photo 1: ECMs observed biological monitors establishing and marking ESAs around active nests discovered during surveys in accordance with MM BIO-7J.

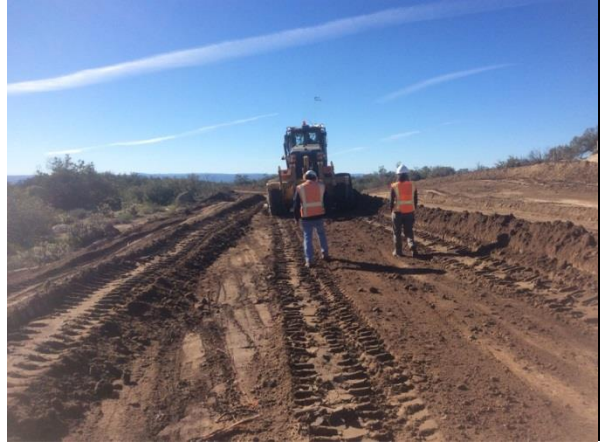
Photo 2: Archaeological and Native American monitors were present during grading activities along the G-String in accordance with MM CUL-1D.

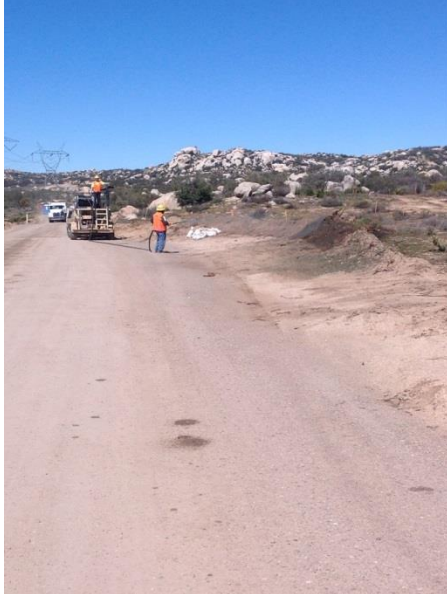
Photo 3: ECMs observed construction crews hydromulching topsoil salvage windrows along McCain Valley Road in accordance with the SWPPP.

In accordance with Section 7.8 of the SWPPP, ECMs observed crews hydromulching topsoil stockpiles. Some of the windrowed stockpiles were temporarily covered with fabric to protect against erosion. The fabric is removed as crews are able to hydromulch and install wattles in accordance with the SWPPP.

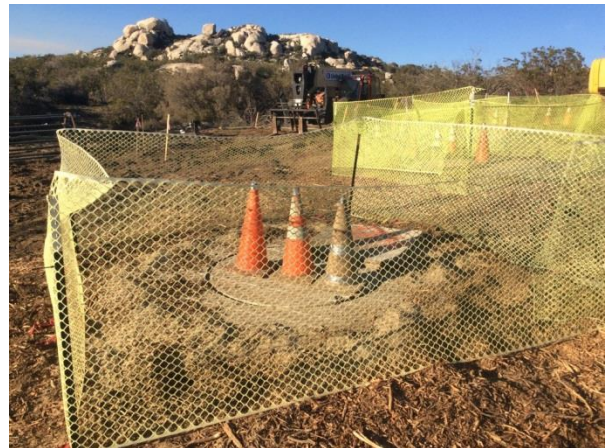
Photo 4: The meteorological tower foundation excavations were covered when not in use to avoid trapping or injuring wildlife in accordance with MM BIO-7A.

Biological monitors were present to monitor initial ground disturbance activities as well as clearing and grubbing activities in accordance with MM BIO-1c. Biological monitors were observed performing nesting bird surveys ahead of clearing and grubbing activities and marking ESAs were established to protect nesting birds discovered during surveys in accordance with MM BIO-7j. ECMs also verified that wildlife ramps were installed in meteorological tower foundation excavations when left open and were covered when possible in accordance with MM BIO-7a.
