BLM Authorized Officer Weekly Report

Project: Tule Wind Energy Project

Weekly Project Update

Reporting Period: 4.10.17 through 4.16.17

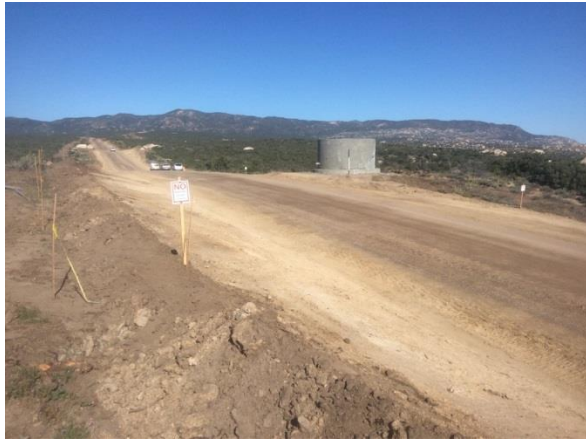
Photo 1: Nesting black throated sparrow ESA at tank 3, within which a Blattner crew was accidentally given permission to work by the ICF designated biologist when signing MSOS documents for the activity. Following identification of the issue, a biological monitor was assigned to the activity in accordance with MM BIO-7j and no impacts to the active nest were observed.

On April 12th, 2017, the ICF designated biologist signed a MSOS mistakenly granting a construction crew permission to work within a drive through nesting bird buffer without a biological monitor present. The mistake was identified when a Dudek 3rd party compliance monitor noticed a vehicle within the buffer and reminded the Blattner construction team that they cannot park a vehicle within a drive through buffer. When the construction crew showed the signed MSOS to the ECM, the ICF designated biologist was contacted and identified the error. A biological monitor was immediately sent to monitor the active bird nest in accordance with MM BIO-7j. ECMs are continuing to work with the construction crews and biological monitors to ensure the required MSOS documents are filled out accurately and that appropriate monitors are present in accordance with the approved mitigation measures.

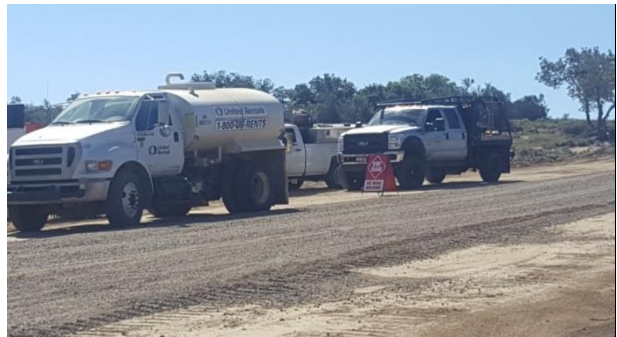
Photo 2: A water truck, fire safety coordinator, and identification signage are located where hot work was occurring in accordance with MM FF-1.

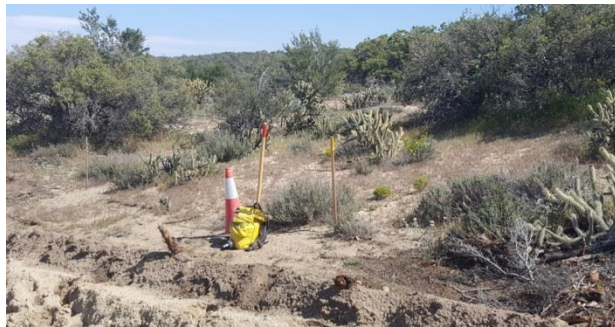
Photo 3: Shovel and a 5-gallon water pack located along McCain Valley Road within 25 feet of an active work area in accordance with MM FF-1.

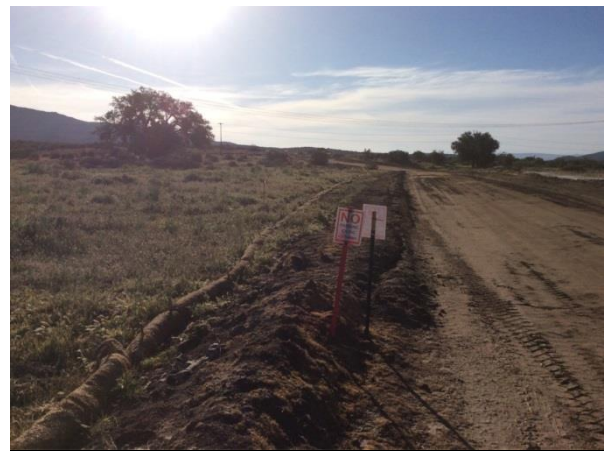
Photo 4: ECMs observed ESA signage for the nesting raptor buffer zone (300'). All construction crews in the vicinity were observed working and parking equipment outside the buffer in accordance with MM-BIO-7J.
