## **BLM Authorized Officer Weekly Report**

**Project:** Tule Wind Energy Project

### **Weekly Project Update**

**Reporting Period:** 4.3.17 through 4.9.17

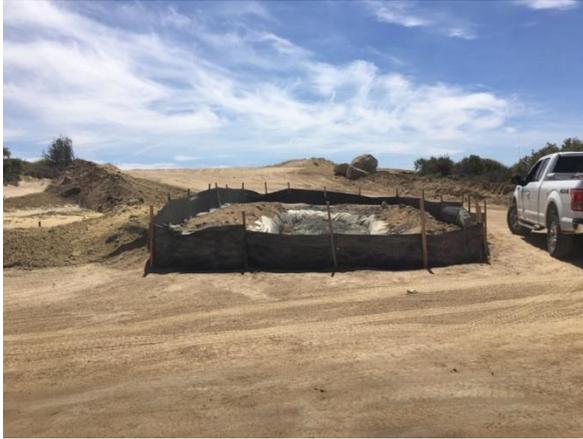
During the previous reporting period on March 28, 2017, ECMs observed a concrete washout at turbine pad G15 without a rock apron as required by design detail WM-8 included in the grading plan. In addition to the missing rock apron, ECMs noted that the washout boundary silt fence required repair. ECMs notified Tule Wind LLC of the issues and on April 7, 2017, ECMs confirmed that both issues at the G15 concrete washout had been resolved in accordance with the SWPPP and grading plan design detail WM-8.

**Photo 1:** ECMs confirmed that the silt fence surrounding the concrete washout at turbine pad G15 was repaired and a rock apron was installed in accordance with the grading plan design detail WM-8.

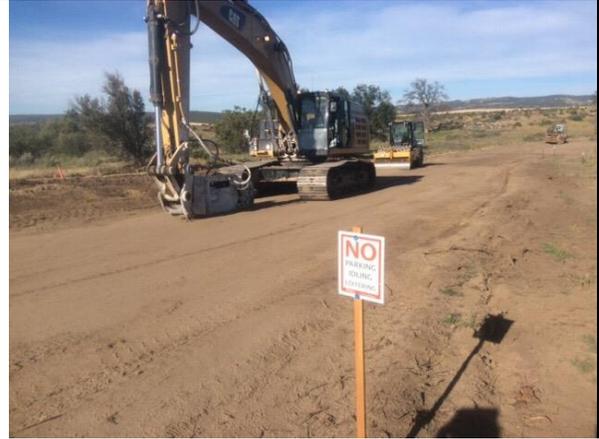
On April 4, 2017, ECMs notified the onsite Designated Biologist when construction crews were observed parking inside an established nesting bird buffer. The ECM identified the “No Parking/Idling/Loitering” signs with the construction crew foreman and asked that the vehicles be moved outside the buffer. The equipment operators immediately moved the equipment.

On April 6, 2017, ECMs observed construction equipment parked within the same nesting bird buffer and reminded the crew foreman of the buffer boundaries and restrictions in accordance with MM BIO-7j. The equipment was moved outside the buffer and no sign of disturbance was observed at the active nest site. On April, 8, the “No Parking/Idling/Loitering” signs were painted pink to increase visibility and remind construction crews of the buffer restrictions. Construction crews were further reminded to abide by all environmental signage and to contact the biological and/or archaeological contractor if there are any questions or concerns.

**Photo 2:** ECMs observed construction equipment parked within an active nesting bird buffer on April 4 and 6, 2017. During both incidents, construction crews were reminded of the buffer restrictions outlined in MM BIO-7J and the equipment was moved. Following the second incident, the "No Parking/Idling/Loitering" signs have been painted pink to increase visibility.

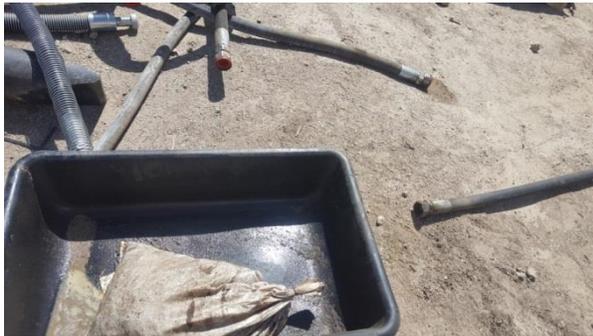
During the previous reporting period, ECMs observed stained soil at laydown yard 11 on March 31, 2017. On the same day, construction crews removed the stained soil and placed it in a secondary containment bin. When ECMs returned to check on cleanup efforts at the laydown yard during the current reporting period, additional stained soil and soiled materials used to clean equipment remained onsite without proper containment. Following notifications to Tule Wind LLC, onsite biological monitors, and the Qualified SWPPP Practitioner; ECMs confirmed that all stained soil and materials were properly contained, cleaned, and removed from the site by April 7, 2017.

**Photo 3:** ECMs reported that stained soil contained during the previous reporting period remained onsite at laydown yard 11, within a secondary containment container not intended for storage or disposal of hazardous materials. Following the identification of additional stained soil and soiled cleaning materials at the laydown yard, construction crews cleaned and removed all stained soil and materials in accordance with MM HAZ-1A.

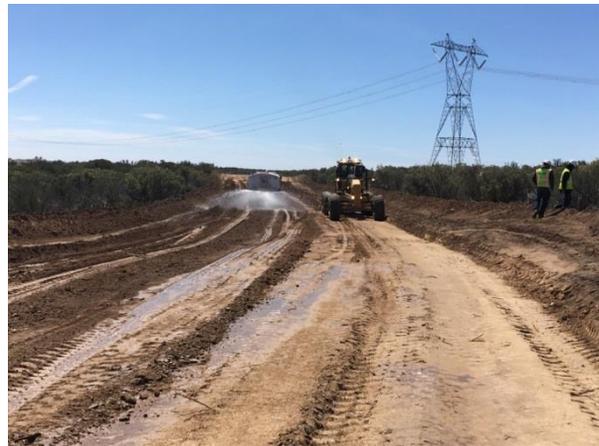
**Photo 4:** ECMs observed archaeological and Native American monitors present during road work along the F String in accordance with MM CUL-1D. Water was also applied regularly during activity along the road to minimize fugitive dust in accordance with MM AQ-1.
