# BLM Authorized Officer Weekly Report

**Project:** Tule Wind Energy Project

## Weekly Project Update

**Reporting Period:** 5.15.17 through 5.21.17

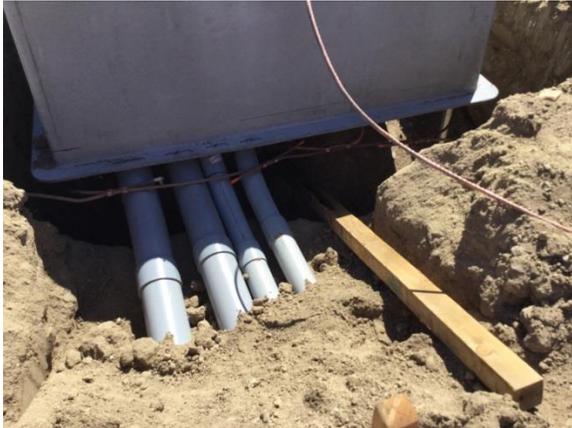
**Photo 1:** ECMs confirmed that wildlife ramps were installed in the open excavation at turbine site G11 in accordance with MM BIO-7A.

On 5/16/2017 and 5/17/2017, ECMs observed open excavations at turbine sites G8, G11, and G12 without proper wildlife ramps. The onsite DB and additional biological monitors were notified of the issue both days. ECMs confirmed ramps had been installed in accordance with MM BIO-7a by the end of the day on 5/17/2017.

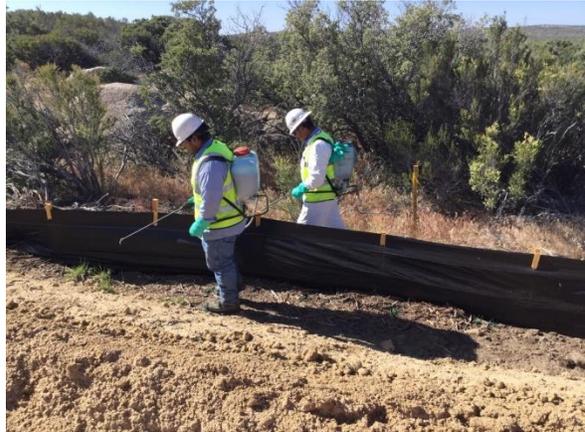
**Photo 2:** Crew spraying herbicide within disturbance limits on A string. A qualified restoration monitor was present per MM BIO-3A.

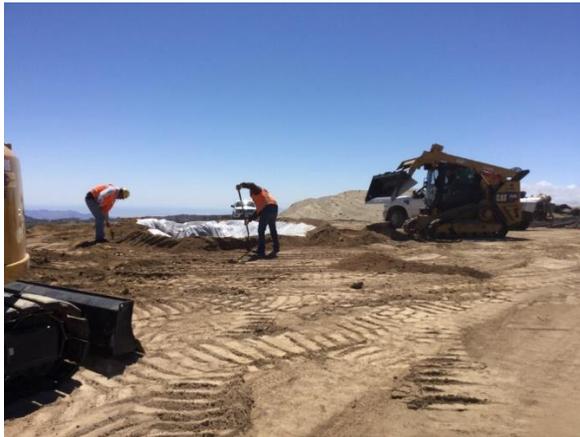
**Photo 3:** Construction crew installing concrete washout basin at turbine pad C3 in accordance with the project SWPPP.

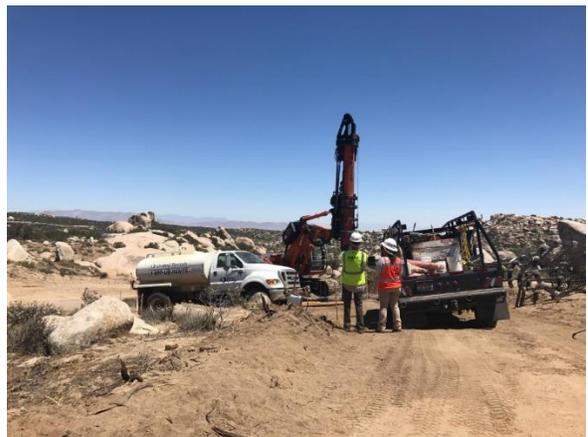
**Photo 4:** ECMs observed drilling along McCain Valley Road. Archaeological and Native American monitors were present to observe the ground disturbance in accordance with MM-CUL-1D.
