BLM Authorized Officer Weekly Report

Project: Tule Wind Energy Project

Weekly Project Update

Reporting Period: 5.22.17 through 5.28.17

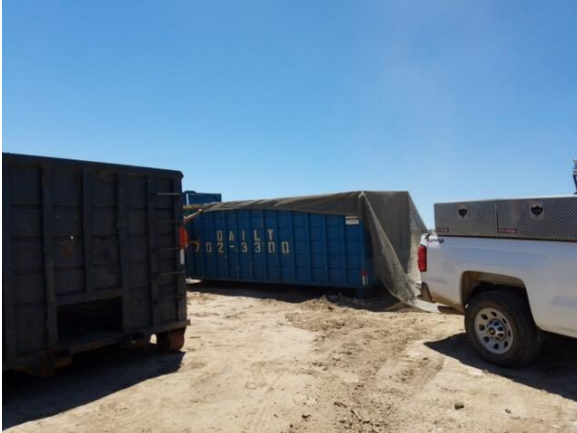
Photo 1: ECMs confirmed that the roll-off bin at laydown yard 11 was covered in accordance with MM BIO-7d.

During the previous reporting period, ECMs observed scrap plastic outside a nearby dumpster staged at lot 6 and food trash left uncovered in a roll-off bin at laydown yard 11. On 05/22/17, ECMs confirmed that the plastic had been removed from lot 6 and the roll-off bin was covered at laydown yard 11 in accordance with MM BIO-7d.

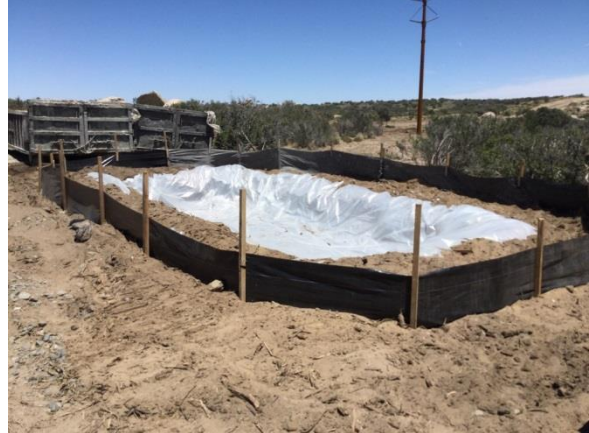
Photo 2: The silt fencing surrounding a concrete washout basin is maintained in good condition. A rock apron is anticipated to be installed at the washout basin in accordance with figure WM-8 of the grading plans.

During this reporting period, ECMs observed construction crews repairing BMPs throughout the project site. There were several issues identified with deficient BMPs including silt fencing and straw wattles in need of repair, concrete washout basins missing rock aprons, and sediment stockpiles at turbine sites G3 and G5 requiring stabilization during inactivity (more than 14 days). Each of these issues were discussed with the designated biologist and were in the process of being addressed. ECMs are preparing a punch list to help identify and address BMP deficiencies.

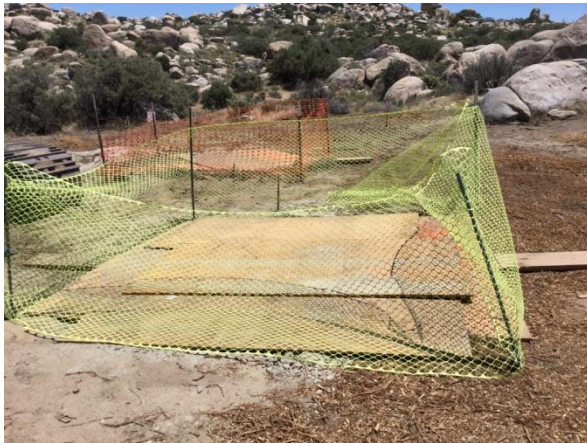
Photo 3: Excavations are covered to prevent wildlife from becoming entrapped in accordance with MM BIO-7A.

On 05/25/17, ECMs recorded that the open excavations at two collector poles were found to be improperly covered. The lead biological monitor was notified of the issue. The following day, ECMs confirmed that the excavation openings had been covered to prevent wildlife entrapment in accordance with MM BIO-7a.

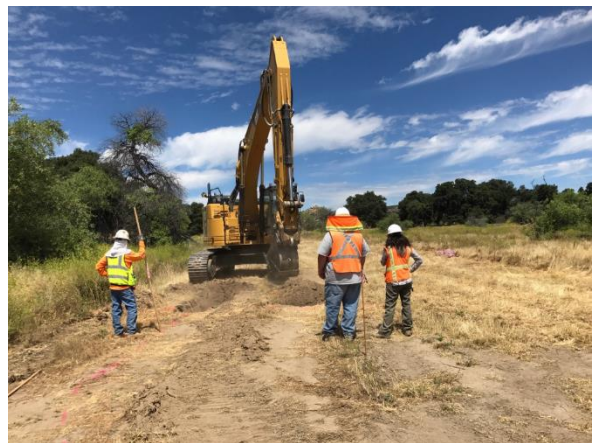
Photo 4: Archaeological and Native American monitors were present for excavations associated with overhead collector pole #25 in accordance with MM CUL-1D.
