BLM Authorized Officer Weekly Report

Project: Tule Wind Energy Project

Weekly Project Update

Reporting Period: 06.05.17 through 06.11.17

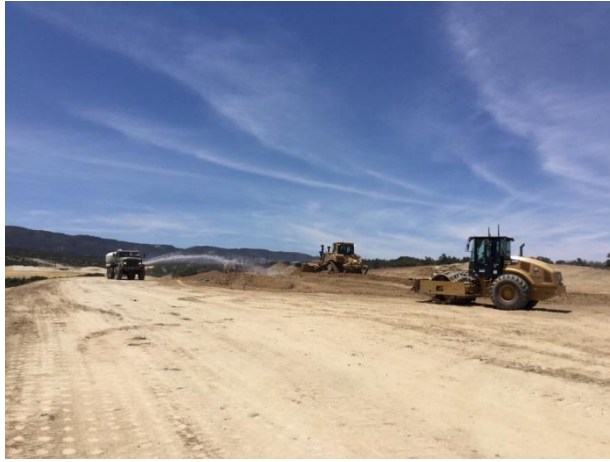
Photo 1: ECMs observed a water truck providing dust control during backfilling at turbine site E-3 in accordance with MM-AQ-1.

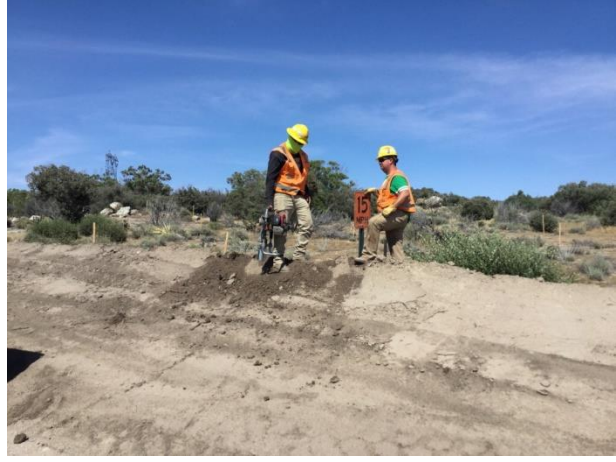
Photo 2: A construction crew is observed adding a speed limit sign along McCain Valley road in accordance with MM-TRA-1.

The construction contractor is anticipated to install two radar speed limit signs along McCain Valley Road to help address the speeding issue. In addition, on 06/08/17 construction crews were observed replacing and installing new traffic control signs including speed limit signs in accordance with MM-TRA-1.

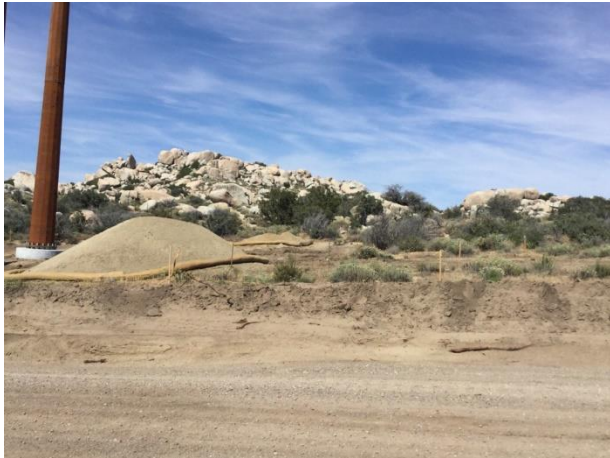
Photo 3: Straw wattles are installed downslope of soil stockpiles at collector pole site 40 in accordance with the project specific SWPPP.

During the previous reporting period, ECMs observed stockpiles at collector pole sites 40 and 41 without straw wattles. On 06/06/17, ECMs conducted a follow-up and observed the proper BMPs installed in accordance with MM-HYD-1.

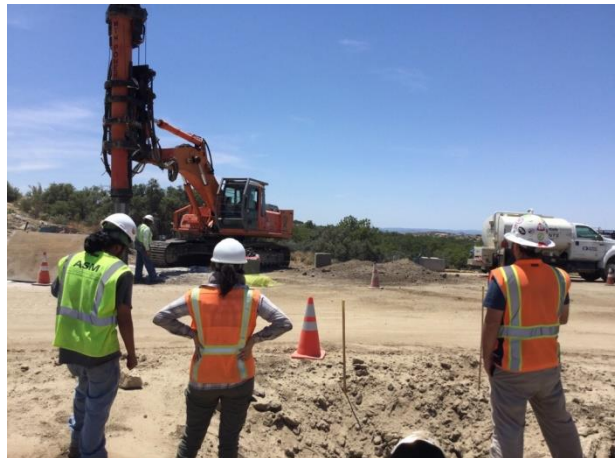
Photo 4: Archaeological, Native American, and biological monitors are present during drilling activities at collector pole location #54 in accordance with MM-CUL-1d and MM BIO-1C.
