BLM Authorized Officer Weekly Report

Project: Tule Wind Energy Project

Weekly Project Update

Reporting Period: 12.18.17 through 12.24.17

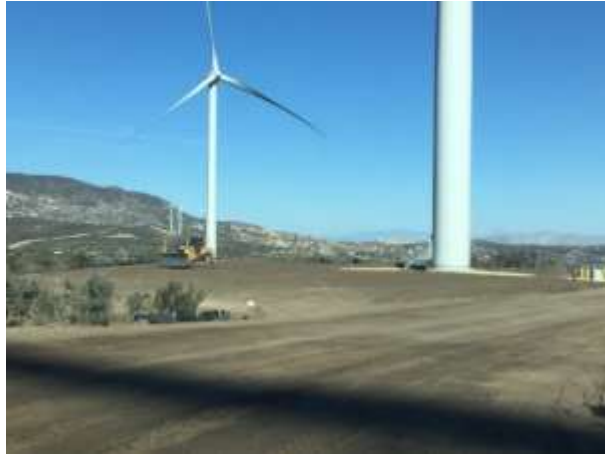
Photo 1: A bulldozer is observed spreading topsoil at turbine pad C-2 in accordance with Section 5.2 of the Habitat Restoration Plan.

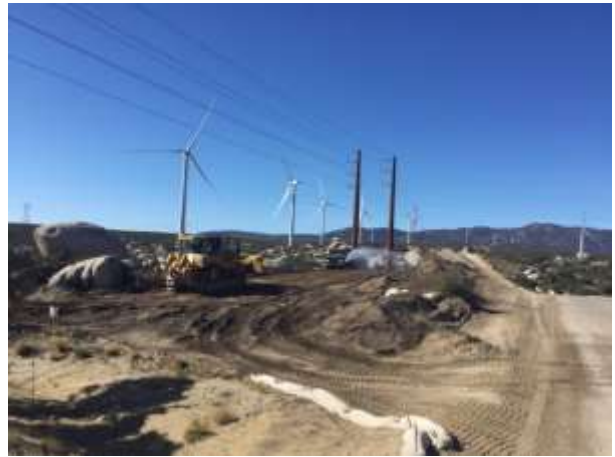
Photo 2: Reclamation/re-contouring activities occurred at overhead collector pole site 23. A water tender applied water in an effort to minimize dust in accordance with MM AQ-1.

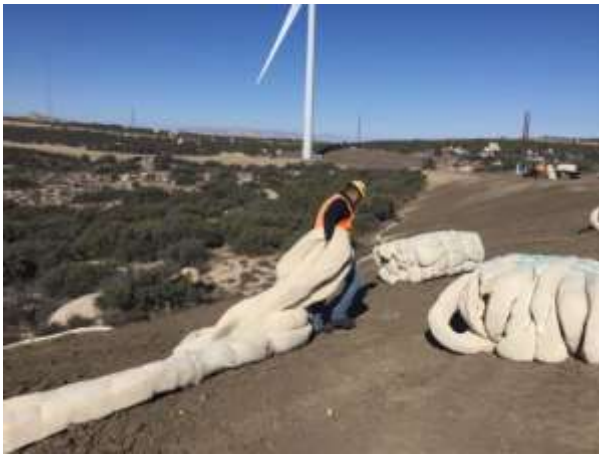
During this reporting period, ECMs observed construction crews removing old silt fencing and straw wattles using a backhoe from the D-1/D-4 access road, installation of fiber rolls at overhead collector poles 40-41, and installation of new straw wattles on the slope of turbine pad E-10, in accordance with the site specific SWPPP and MM HYD-1.

Photo 3: A construction worker is observed installing straw wattles along the slope at turbine pad E-10, in accordance with site specific SWPPP.

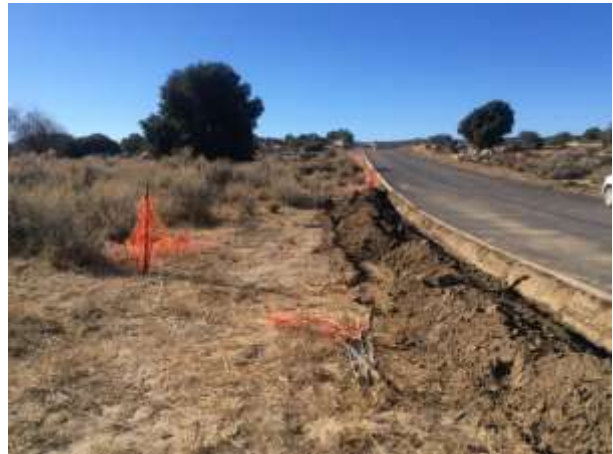
On 12/19/2017, construction crews excavated a trench along Rough Acres Ranch Road without an archaeologist or Native American monitor present. A portion of the trench that was excavated traverses an environmentally sensitive area (ESA). The ESA was delineated with t-posts and orange snow fencing. The construction crew who excavated the trench removed the ESA posts and fencing without authorization.

The construction contractor notified Tule Wind LLC's archaeological contractor, ASM of the trenching activity after a trench extending approximately 77 feet had been dug. When ASM's archaeological monitor observed that a trench had been dug without archaeological or Native American monitors present, the archaeological monitor requested that no additional construction activities occur along Rough Acres Ranch Road until the monitor could assess the situation.

The BLM's third party archaeological monitor, ASM's Senior Archaeologist, and ASM's archaeological monitor inspected the trench and associated spoils pile and did not observe any archaeological resources. No additional construction activities occurred along Rough Acres Ranch Road for the day as a result of this incident. ASM installed t-posts and rope around the trench to prevent unauthorized access. Subsequently, ASM archaeologists conducted sample screening of the spoils piles. No archaeological resources were identified in the sample screening effort.

This incident has been documented as a serious violation in accordance with Section 5.2 of the ECMP. The ECMP defines a serious violation as “an activity that is not in compliance with the project specifications and causes substantial harm to resources or poses a serious threat to sensitive resources or worker/public safety”. While no resources were affected as a result of this incident, it did pose a serious threat to sensitive resources.

Photo 4: Looking west along Rough Acres Ranch Road where ESA fencing was removed and trenching occurred without an archaeologist or Native American monitor present. This incident was documented as a serious violation by the BLM.
