BLM Authorized Officer Weekly Report

Project: Tule Wind Energy Project

Weekly Project Update

Reporting Period: 12.26.16 through 1.1.17

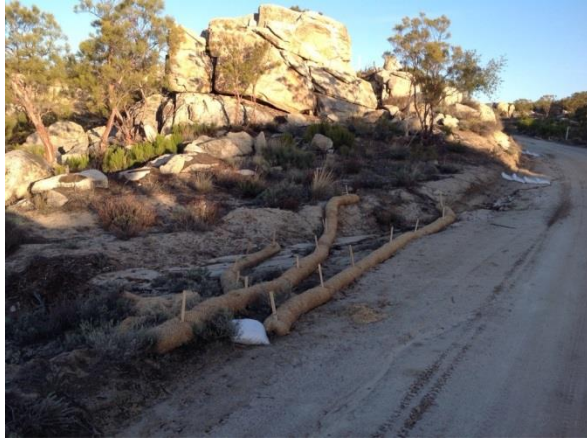
Photo 1: Previously installed erosion control devices along McCain Valley Road reinforced with an additional sand bag and straw wattle following the site-wide SWPPP inspection in accordance with the SWPPP and MM HYD-1.

On Tuesday, December 27, 2016 ECMs verified that a site-wide SWPPP inspection occurred following the holiday weekend and recent rain events in accordance with Section 8.0 of the SWPPP. The majority of the erosion and sediment control devices were observed to be in good condition without sediment discharge. During this reporting period, additional erosion and sediment control devices were installed and existing devices were reinforced or maintained along McCain Valley Road to prevent project runoff in accordance with MM HYD-1.

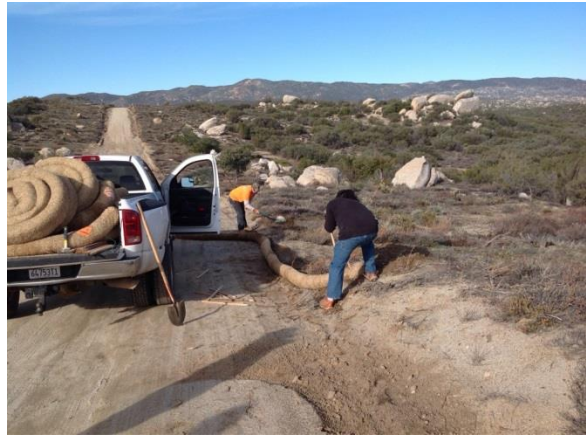
Photo 2: Crews installing additional straw wattles along McCain Valley Road in accordance with the SWPPP and MM HYD-1.

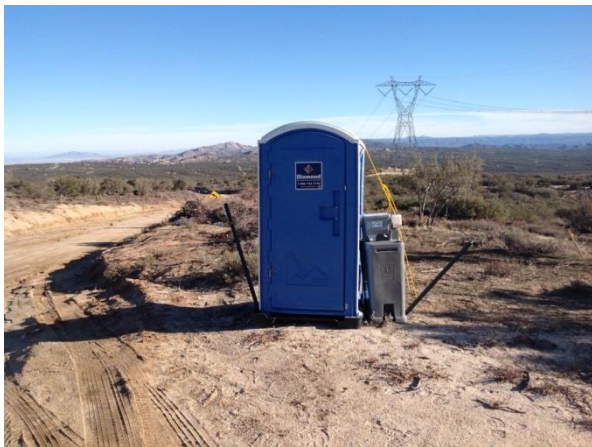
Photo 3: Portable sanitation facility, along McCain Valley Road, secured with rope in accordance with ROW Grant Stipulation 78 and the Hazardous Materials Management Plan.

On Tuesday, December 27, 2016 a portable sanitation facility, which was previously secured using a tie-down strap, was discovered overturned with the strap missing on McCain Valley Road near the B String. ECMs observed no fluid discharge from the overturned facility and determined that no cleanup was required. The facility was righted and secured upright with rope to prevent the potential for leaks or spills in accordance with ROW Grant Stipulation 78 and the Hazardous Materials Management Plan.

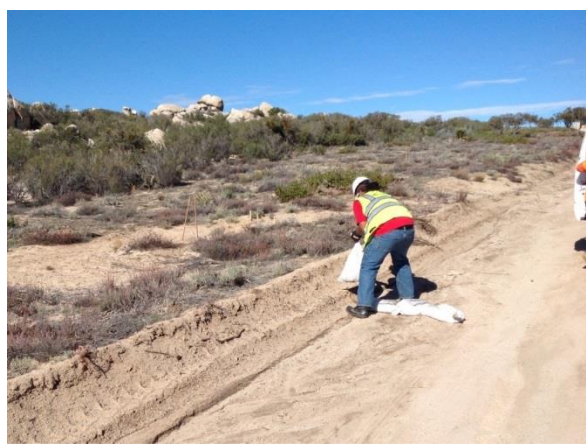
Photo 4: Crews installing additional sand bags at areas subject to overland flow during rain events along McCain Valley Road in accordance with the SWPPP and MM HYD-1.
