BLM Authorized Officer Weekly Report

Project: Tule Wind Energy Project

Weekly Project Update

Reporting Period: 12.12.16 through 12.18.16

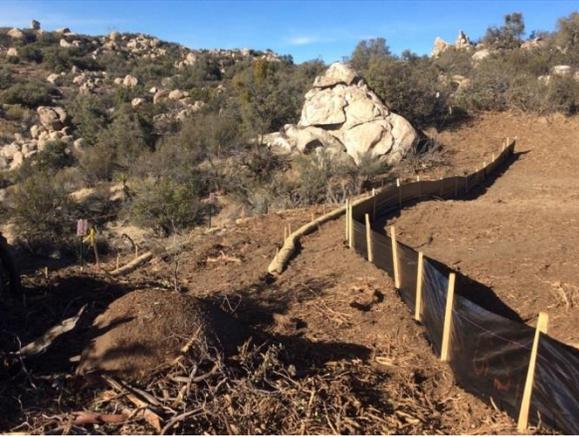
Photo 1: Erosion and sediment control devices properly installed in accordance with the SWPPP.

ECMs observed the proper installation of erosion and sediment control devices including straw wattles and silt fencing. Erosion and sediment control devices were being installed per the specifications provided in the grading plans and in accordance with the SWPPP.

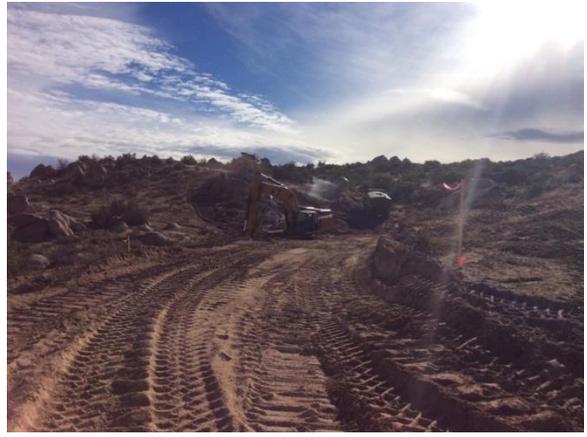
Photo 2: Clearing and grading activities observed within the staked limits of disturbance in accordance with MM BIO-1A.

During this reporting period, grading and clearing activities continued along the J string and G string access roads as well as temporary staging areas in accordance with NTP-4. Topsoil was salvaged along the ROW in accordance with Section 5.2.2.3 of the Habitat Restoration Plan.

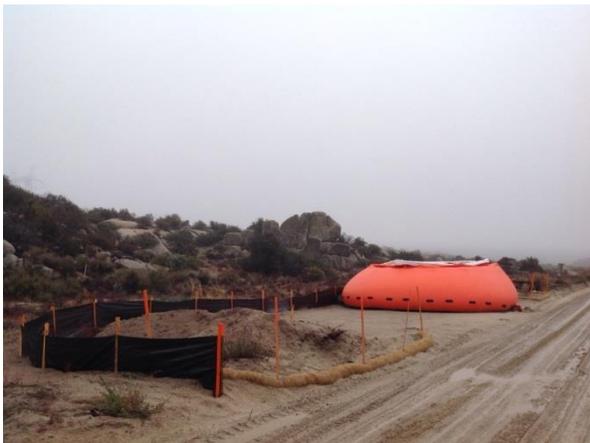
Photo 3: Temporary 10,000-gallon water tanks installed with proper erosion and sediment control devices in accordance with the Fire Prevention/Protection Plan, NTP-3, and the SWPPP.

On Saturday, December 12, 2016 four 10,000-gallon temporary water tanks were installed along McCain Valley Road in accordance with the Fire Prevention/Protection Plan and NTP-3. With the installation of the four 10,000-gallon temporary water tanks, clearing and grading activities on land administered by the BLM were authorized to proceed.

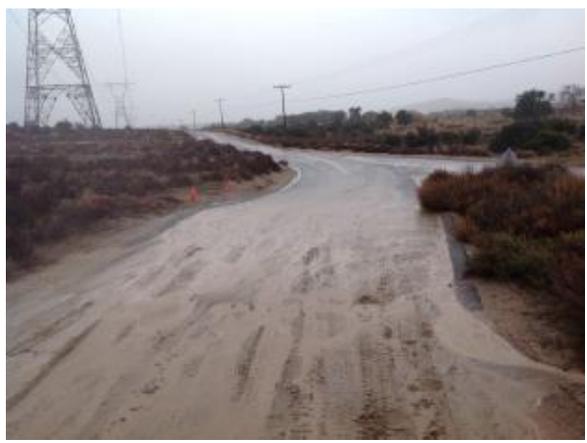
On Friday, December 16, 2016, the BLM's third-party ECM noted that the entrance/exit at the paved portion of McCain Valley Road was not stabilized in accordance with section 7.6 of the SWPPP. ECMs notified Tule Wind LLC of the track-out at the paved portion of McCain Valley Road. Tule Wind LLC was aware of the issue and will be working with the BLM and San Diego County to stabilize the entrance/exit with gravel to prevent track-out, while not impeding or restricting the public's use of the area.

Photo 4: ECMs noted that McCain Valley Road is not properly stabilized at the paved entrance/exit in accordance with the SWPPP. Tule Wind LLC is aware of the issue and is working to stabilize the entrance/exit without impeding public access.
