BLM Authorized Officer Weekly Report

Project: Tule Wind Energy Project

Weekly Project Update

Reporting Period: 6.12.17 through 6.18.17

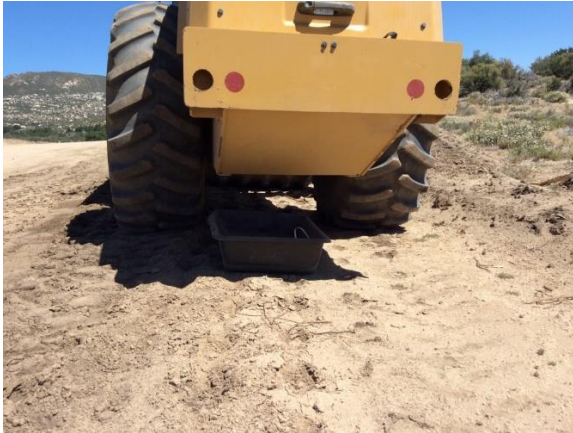
Photo 1: ECMs observed drip pan containment bins beneath construction equipment in accordance with MM-HAZ-1.

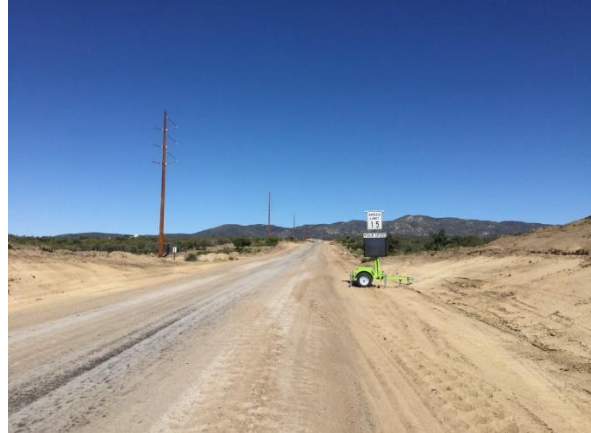
Photo 2: Two speed limit radar signs were staged along McCain Valley Road to remind construction vehicles of the project speed limit and prevent speeding in accordance with MM-BIO-7B.

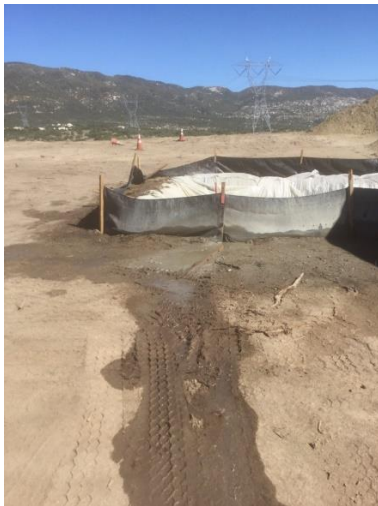
On 06/15/17, ECMs observed that the concrete washout near turbine B2 had concrete/water mixture leaking outside of the silt fence and onto the soil. The lead biologist was notified of the issue and the issue was addressed by repairing the plastic lining in the washout basin and ensuring that the washout basin does not exceed its capacity.

Photo 3: ECMs observed excess concrete/water mixture outside of the silt fencing in multiple locations. The construction contractor was notified to install gravel aprons in accordance with the Grading Plans (please see Photo 4) and to not fill washout basins beyond capacity.

On 06/15/17, ECMs observed a concrete truck driver that had underestimated the distance to the washout pit and released the washout onto the ground instead of the prescribed pit. The construction foreman was contacted and he stated that he would install rock aprons in accordance with the project grading plans. The washout that affected the ground surface was appropriately cleaned and disposed of.

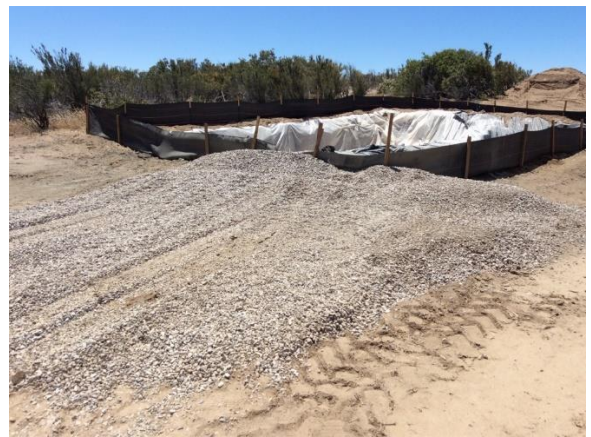
Photo 4: Gravel apron installed as a best management practice (BMP) to prevent concrete washout discharge in accordance with the Grading Plans.
