BLM Authorized Officer Weekly Report

Project: Tule Wind Energy Project

Weekly Project Update

Reporting Period: 3.27.17 through 4.2.17

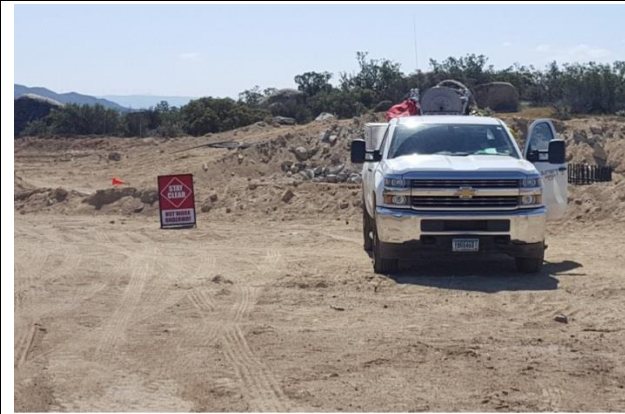
Photo 1: Fire safety coordinator and required signs were present during Hot Work at turbine pad G12 in accordance with the issued Hot Work Permit and MM FF-1.

Hot work permits were issued for tower foundation work along the G-String and ECMs verified that Fire Watch personnel, as well as proper equipment and signage, were present in accordance with the hot work permit and MM FF-1.

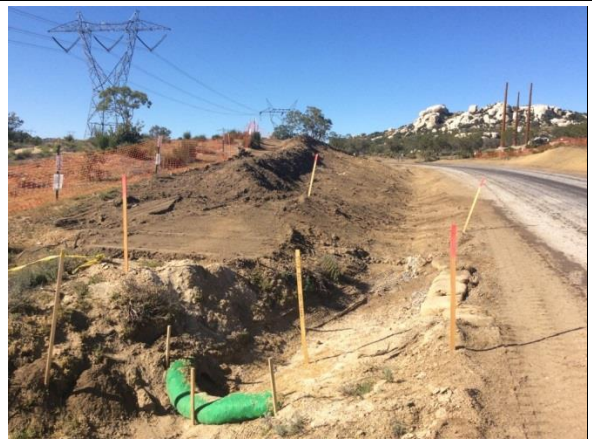
Photo 2: Erosion and sediment control ditches and straw wattles were installed along McCain Valley Road in accordance with the SWPPP.

During this reporting period, construction crews installed biodegradable and weed-free straw wattles, silt fencing, dug a retention basin, and installed road ditches across the site. Construction crews hydromulched salvaged topsoil to stabilize installations along McCain Valley Road in accordance with Section 7.8 of the SWPPP.

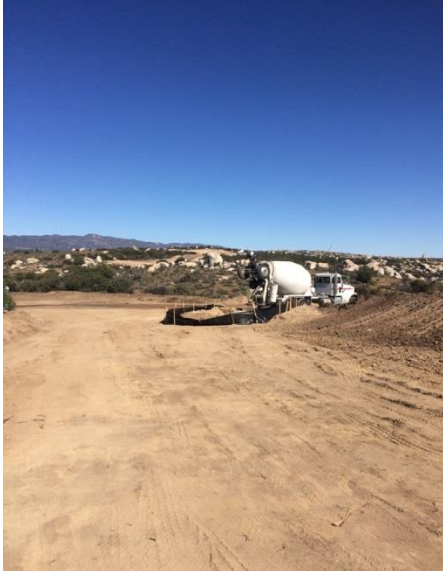
On March 28, 2017, ECMs observed a concrete washout at turbine pad G15 without a rock apron as required by design detail WM-8 included in the grading plan. ECMs notified Tule Wind, LLC of the problem area and are working with the construction contractor to make sure a rock apron is installed per design detail WM-8.

Photo 3: ECMs observed the concrete washout at turbine pad G15 without a rock apron as required by design detail WM-8 included in the grading plans. ECMs notified Tule Wind, LLC of the problem area. A rock apron is anticipated to be installed in accordance with the grading plans.

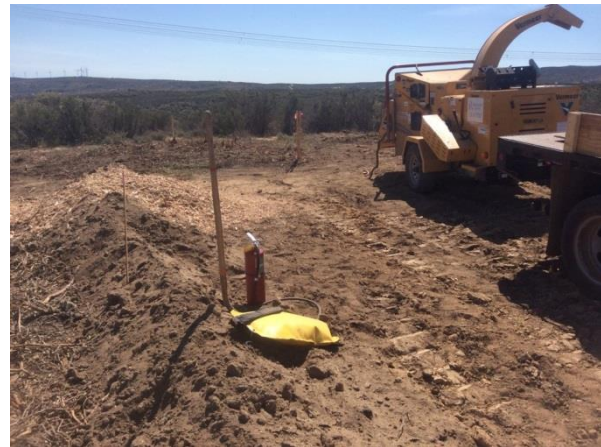
Photo 4: ECMs confirmed that the required fire prevention equipment was present within the vicinity of chipping operations along McCain Valley Road in accordance with MM FF-1.

ECMs observed best management practices on the project site during construction activities, including vehicles with required fire suppression equipment, required fire suppression equipment on site within required distances, vehicles parked in areas with no vegetation, and the wetting of vegetation ahead of clearing activities. Fire patrols occurred one hour after the end of daily construction in accordance with MM FF-1.
