BLM Authorized Officer Weekly Report

Project: Tule Wind Energy Project

Weekly Project Update

Reporting Period: 4.24.17 through 4.30.17

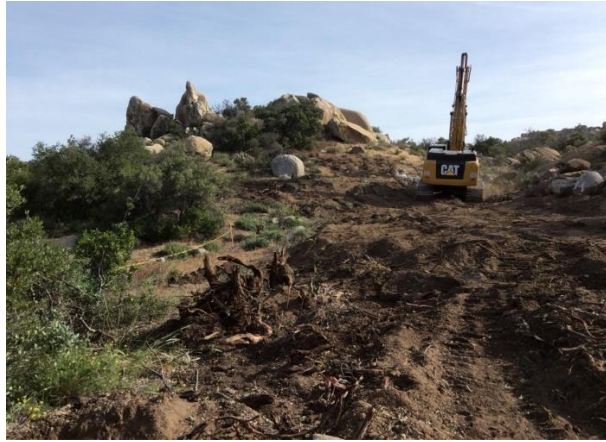
Photo 1: ECM's observed rock breaking at J string access road, with yellow tape shown delineating work limits in accordance with the February 1, 2017 NTP.

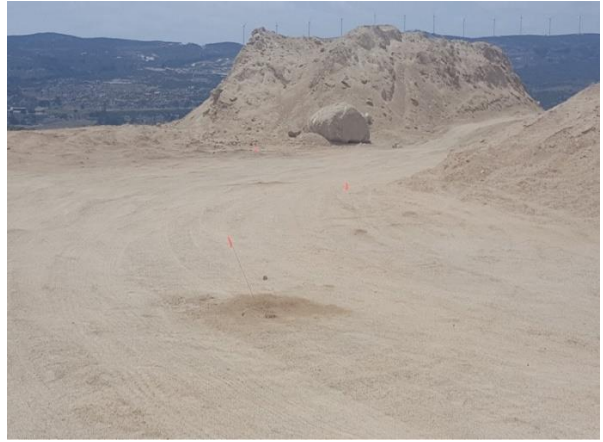
On April 25th, 2017 ECMs observed multiple stained soil sites at turbine pad site G15. The stained soil was flagged and the designated biologist and contractor superintendent were contacted. On April 27th, ECMs confirmed that all stained soil sites were properly contained, cleaned, and removed from the site in accordance with MM-HAZ-1a.

Photo 2: ECM's observed flagged, stained soil sites at turbine pad G15.

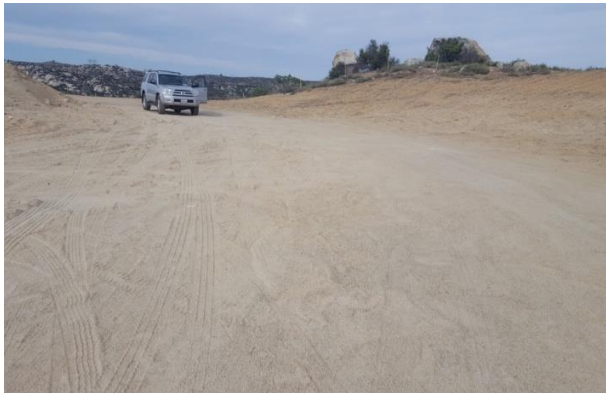
Photo 3: ECMs confirmed that stained soil was removed from the site G15, in accordance with MM HAZ-1A.

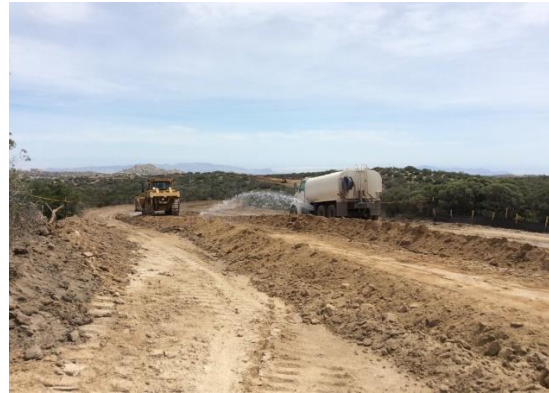
Photo 4: ECMs observed road grading on the access road between pad sites C2 and C5 with an accompanying water truck in order to minimize fugitive dust as per MM AQ-1. Yellow tape is shown marking limits of disturbance in accordance with the February 2, 2017 NTP.
