## **BLM Authorized Officer Weekly Report**

**Project:** Tule Wind Energy Project

### **Weekly Project Update**

**Reporting Period:** 07.31.17 through 08.06.17

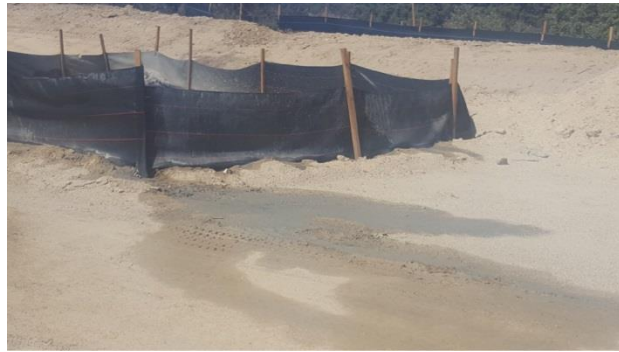
On Friday 8/4/17, concrete washout was observed outside the designated containment area and silt fence along the C line. The designated biologist was notified of the issue and clean up occurred the same day.

**Photo 1:** On August 4, 2017, ECMs recorded concrete washout that had flowed outside the established washout containment and silt fence along C line. The designated biologist was notified.

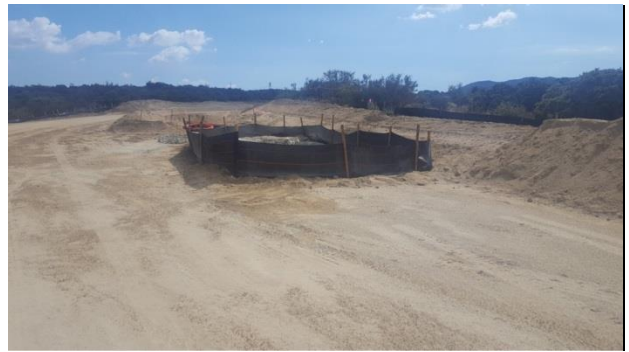
**Photo 2:** On August 4, ECMs confirmed that the concrete washout outside the containment area along C line had been cleaned up in accordance with the SWPPP.

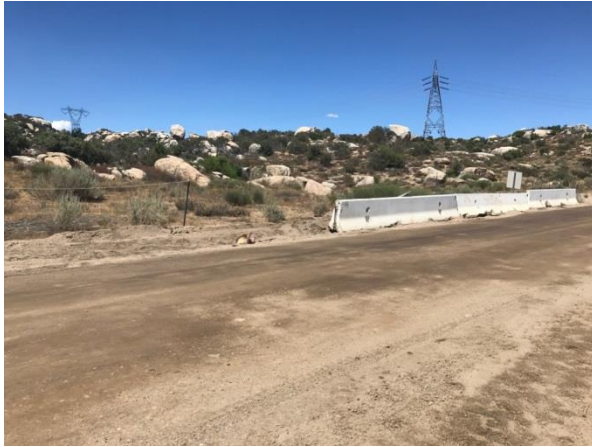
**Photo 3:** ECMs observed K-rails placed along McCain Valley Road to protect an established ESA during component delivery and additional road work in accordance with the approved Variance Request 010.

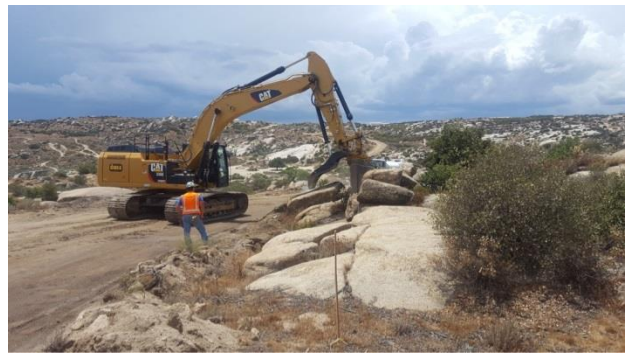
During this reporting period, ECMs observed construction crews moving rocks outside the limits of disturbance north of J line with appropriate resource monitors onsite to perform preconstruction inspections of the work area and to monitor the work as it occurred. The work was performed and recorded per the protocols established by Variance Request 006.

**Photo 4:** During this reporting period, ECMs and applicable monitors were present to perform preconstruction inspections and required monitoring of the rock relocation outside of work limits north of J line in accordance with the approved Variance Request 006.
