BLM Authorized Officer Weekly Report

Project: Tule Wind Energy Project

Weekly Project Update

Reporting Period: 08.21.17 through 08.27.17

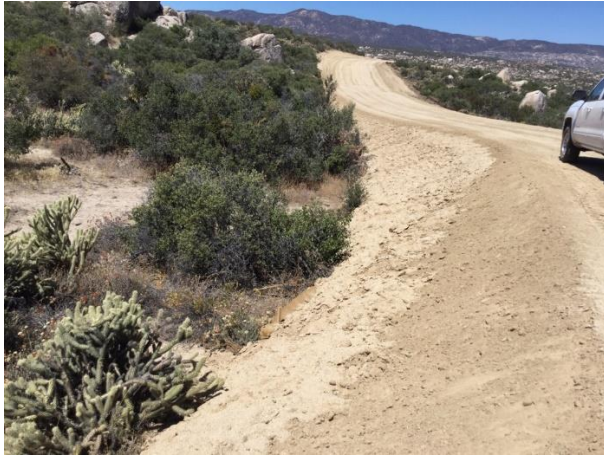
On 8/25/17, ECMs observed straw wattles submerged in soil at the entrance of turbine pad D-4 and the D-2 and D-4 access roads. ECMs will continue to monitor and report potential issues to ensure that they are addressed in a timely manner.

Photo 1: ECMs observed straw wattles buried beneath soil at the entrance to turbine site D-2. The designated biologist was notified of the issue and ECMs will continue to monitor this issue.

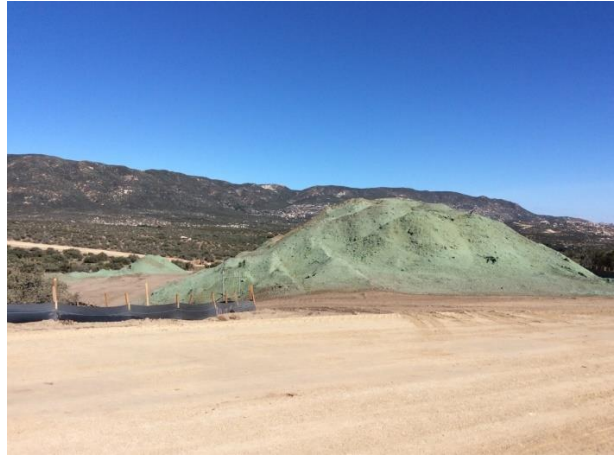
During this reporting period, ECMs observed construction crews applying soil stabilizer on top soil piles at overhead collector pole #1 and hydro seeding slopes and soil piles at laydown yard #2 and turbine site C-1 in order to minimize soil loss from the construction area in accordance with MM-HYD-1 and the project specific SWPPP. Additionally, ECMs observed construction crews cleaning straw wattles and collecting trash along McCain Valley Road between the E and F-lines and near the B-line.

Photo 2: ECMs observed top soil piles at laydown yard #2 stabilized with a soil binder to help minimize top soil erosion in accordance with section 7.3 of the site specific SWPPP.

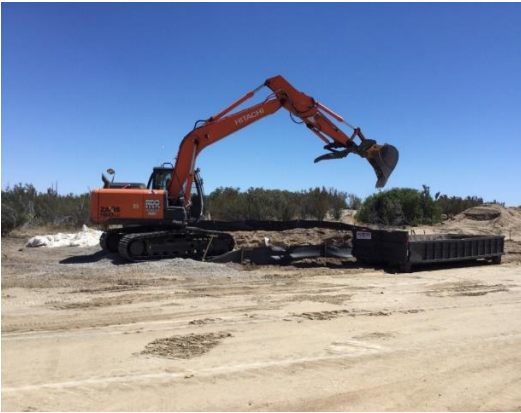
On 8/22/17, during concrete washout reclamation in laydown yard #6, ECMs observed construction crews backfilling the basin while remnants of the plastic liner and concrete waste remained in the pit. ECM notified the operator that the remaining plastic and concrete needed to be removed before backfilling. A biological monitor arrived and concurred with the ECM. The issue was resolved with the construction crew removing the remnants of plastic and concrete from the pit before backfilling resumed.

Photo 3: ECMs observed concrete washout reclamation in laydown yard #6.

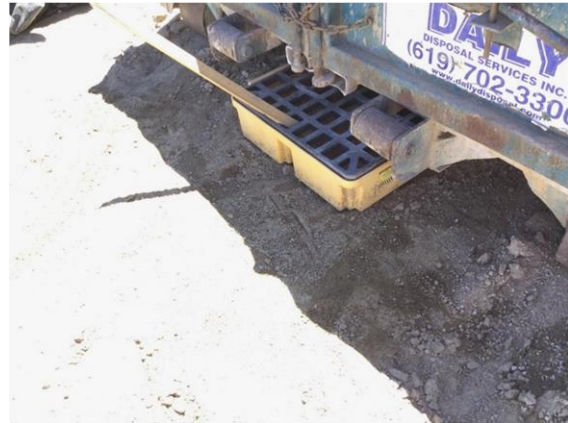
On 8/25/17, ECMs observed a temporary roll off dumpster used as a concrete washout at turbine pad G-5. The dumpster leaked washout onto the soil. As a corrective action, a containment bin was placed beneath the dumpster, but the stained soil remains to be cleaned. The designated biologist was notified of the stained soil beneath the roll off dumpster and ECMs are anticipated to verify the stained soil has been properly cleaned on a follow up inspection. ECMs will continue to monitor and report potential issues to ensure that they are addressed in a timely manner.

Photo 4: ECMs observed containment bins beneath roll off dumpsters being used as temporary washout basins to prevent washout from leaking onto the ground surface.
