BLM Authorized Officer Weekly Report

Project: Tule Wind Energy Project

Weekly Project Update

Reporting Period: 10.23.17 through 10.29.17

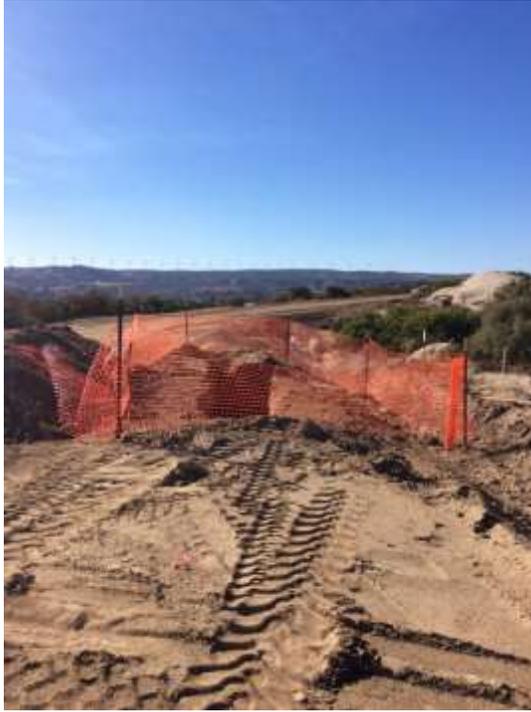
Photo 1: ECMs observed a fenced in junction box by turbine pad G-15 to prevent wildlife entrapment, in accordance with MM BIO-7a.

ECMs observed a junction box by turbine pad G-15 fenced in to prevent wildlife entrapment in accordance with MM BIO-7a.

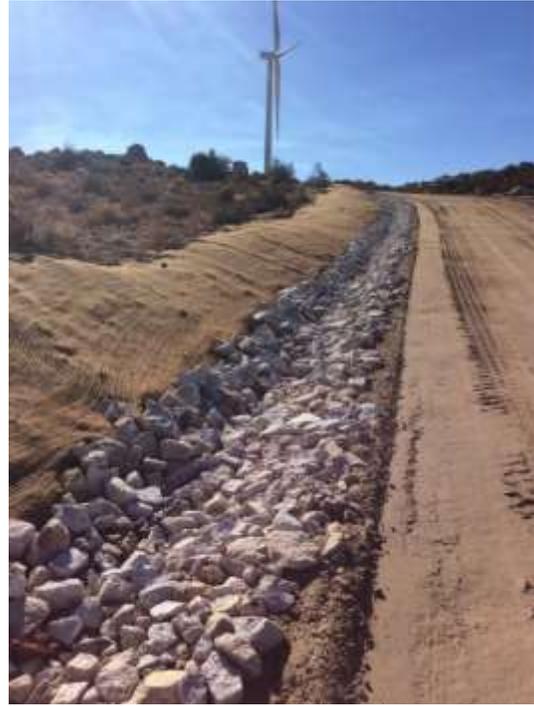
Photo 2: ECMs observed completed riprap installation and fiber mats on the south G-line access road in, accordance with the site specific SWPPP.

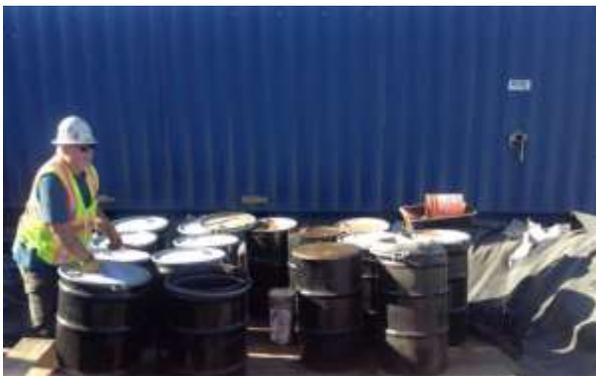
Photo 3: ECMs observed storage area for onsite waste containment to be well maintained in accordance with MM HAZ-1c.

ECMs also observed well-maintained hazardous waste containment areas in accordance with MM HAZ-1c.

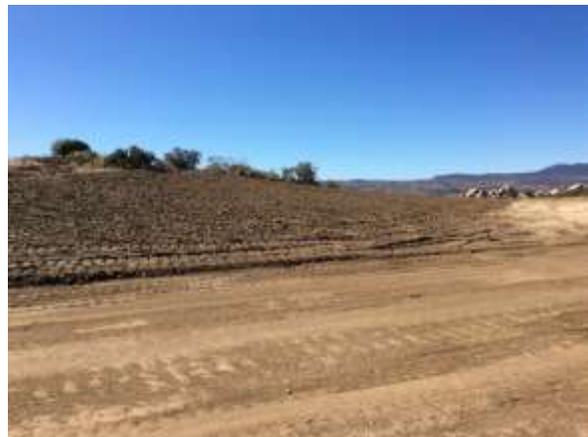
Photo 4: ECMs observed completed turbine pad and soil reclamation along the G-line, per the Habitat Restoration Plan, MM BIO-1D.

On 10/24/17, ECMs observed turbine pad and road shoulder reclamation along the G-line per the Habitat Restoration Plan, in accordance with MM BIO-1d.
