# BLM Authorized Officer Weekly Report

**Project:** Tule Wind Energy Project

## Weekly Project Update

**Reporting Period:** 11.06.17 through 11.12.17

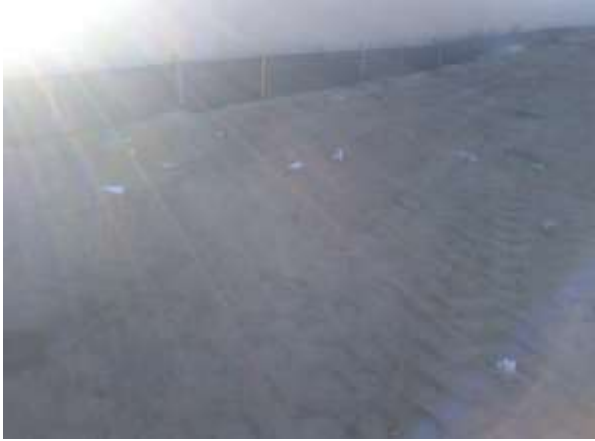
On 11/6/2017, ECMs observed the main laydown yard to be littered with trash, which was blown to turbine pads G-2 and G-5 as a result of strong winds. ECMs also discovered two small, uncovered trashcans. The ECM notified nearby construction crews and the areas were cleaned and the trash appropriately disposed of shortly thereafter in accordance with MM-BIO-7d.

**Photo 1:** ECMs observed trash littered in the main laydown yard. ECMs notified construction crews and trash was cleaned and properly disposed of shortly thereafter in accordance with MM-BIO-7d.

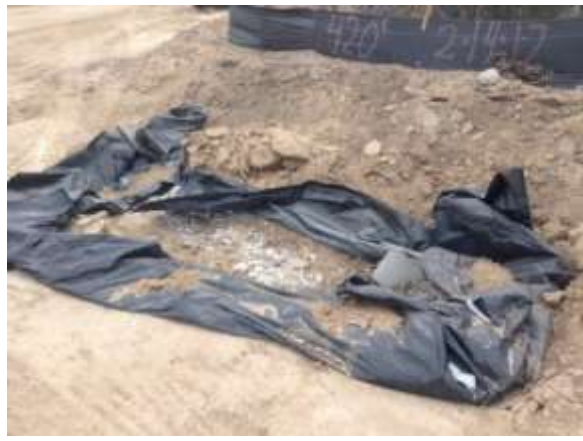
On 11/6/2017, ECMs observed a concrete washout basin near turbine pad F-2 in poor condition. ECMs notified the designated biologist to replace the washout basin in accordance to project site specific SWPPP.

**Photo 2:** ECMs observed a wash out basin near turbine pad F-2 in poor condition. ECMs coordinated with the designated biologist to repair the wash out basin, in accordance with the project site specific SWPPP.

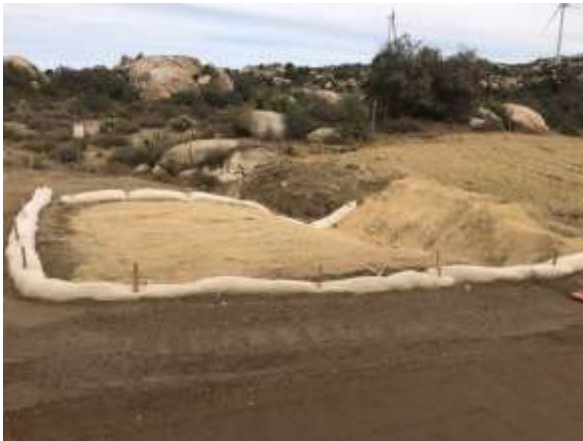
During this reporting period, ECMs observed crews performing erosion control maintenance at BMPs along McCain Valley Road, in accordance with the site specific SWPPP and MM HYD-1.

**Photo 3:** Installation of straw wattles and fiber blankets continued along McCain Valley Road, in accordance with the project site specific SWPPP and MM HYD-1.

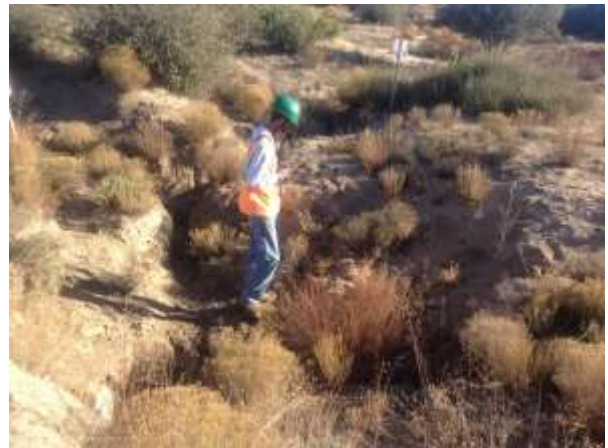
On 11/11/17, the protocols of variance request 006 were implemented in order to extend four culverts. No impacts to special status flora or fauna were observed. Full time biological, cultural, and archeological monitoring were present in accordance with MM BIO-1c and MM CUL-1d.

**Photo 4:** ECMs observed an archaeological monitor inspecting culverts per the protocols of Variance Request 006 and in accordance with MM CUL-1d.
