BLM Authorized Officer Weekly Report

Project: Tule Wind Energy Project

Weekly Project Update

Reporting Period: 12.11.17 through 12.17.17

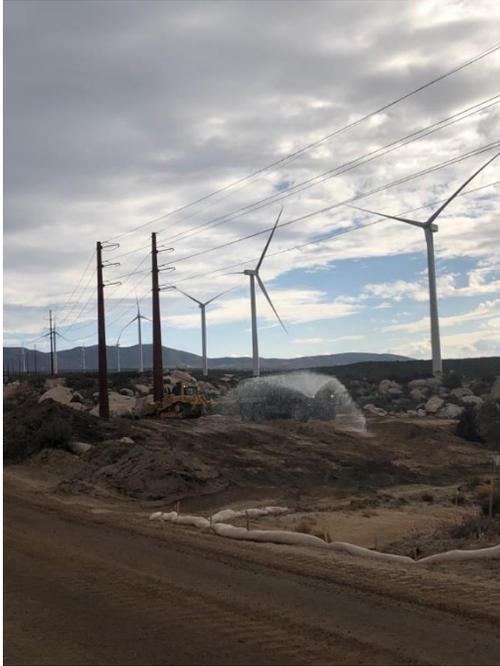
Photo 1: An ECM observed a water truck applying water during earthwork activities to control and minimize dust in accordance with MM AQ-1 and the Dust Control Plan.

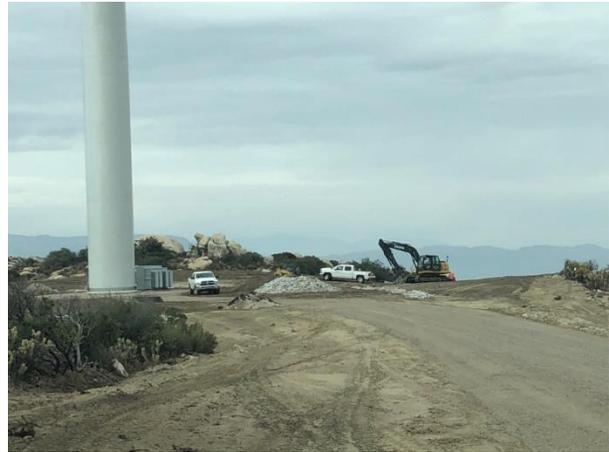
Photo 2: An ECM observed reclamation work taking place interior to the grading limits in accordance with MM BIO-1a.

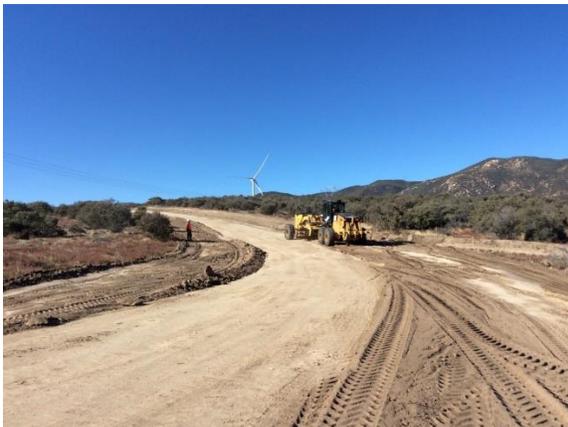
Photo 3: An ECM observed biological monitors monitoring shoulder reclamation along the B-line access road in accordance with MM BIO-1c.

On 12/15/2017, construction crews were using a bulldozer with a blade attachment to reclaim shoulders along the B-line access road. During the reclamation efforts, the protocols of Variance Request 006 were implemented to account for disturbance outside of the staked limits of disturbance. Biological, archaeological, and third party ECMs were present to observe the activity and record the amount of disturbance outside of the approved disturbance limits. An area measuring approximately 1,255 square feet was recorded as being disturbed beyond the limits of disturbance. No sensitive resources were affected.

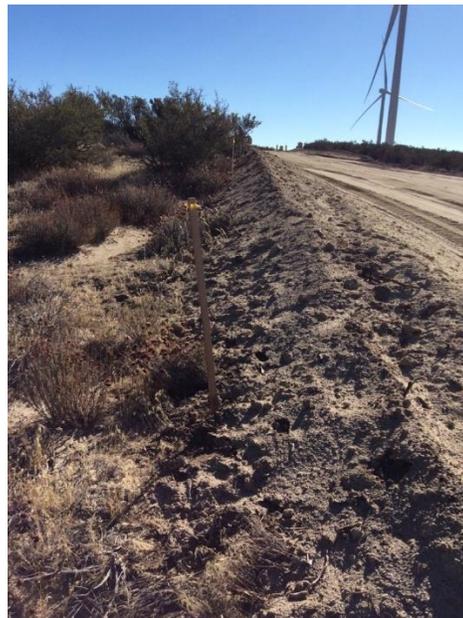
Photo 4: The protocols of Variance Request 006 were implemented to allow for disturbance beyond the staked limits of disturbance during road reclamation activities.
